ABSTRACT

This study analyzed the damage to a slitting knife after cutting steel sheets. Damages to the structure were observed and wear tests were conducted. In addition, the degradation on the damaged and undamaged parts was compared with a Vickers hardness test. Weibull statistical analysis was carried out in order to evaluate the reliability of the Vickers hardness measured data. Spalling of the edge portion occurred by degradation during use over a long period. Rough parts in the specimens were caused by damage because the slitting knife was used for 1 year. The friction coefficient and wear loss at the damaged parts of the knife edge were slightly larger from shock due to repetitive cutting operation. The Vickers hardness followed a two-parameter Weibull probability distribution.

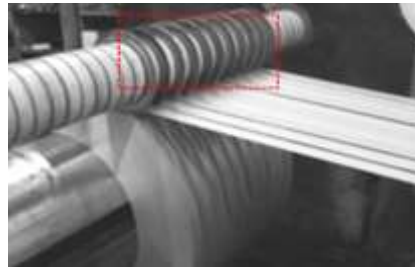
Fig. 1 Appearance of slitting knife

Fig. 1 shows the appearance of the slitting knife. This was used during one year on site of automobile parts manufacture. This has peeling the surface by the degradation.

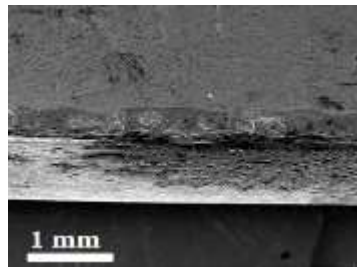
Fig. 4 Spalling failures at the slitting knife edge

Fig. 4 shows a damaged part of the slitting knife. The circle shows the edge of the slitting knife and outlines the damage to the material in contact with the steel sheet. The damaged area exhibits a spalling pattern from the vibration caused by contact with the upper and lower molds. This degraded the hardened layer of the surface with repetitive cutting action, and was peeled off by an external shock.

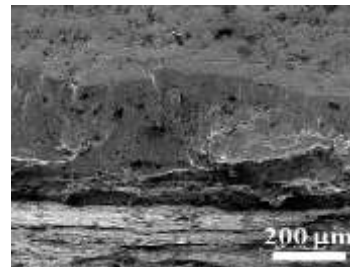
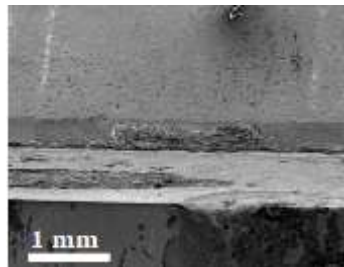
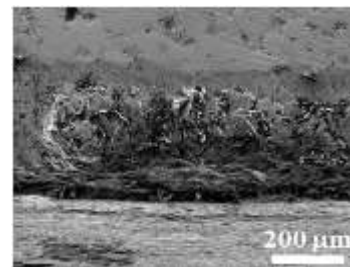
Fig. 5 SEM photograph of spalling failure parts from Fig.4

Fig. 5 is the SEM observation result for Fig. 4 and illustrates the damage from the impact caused by rotation. Peeled parts containing a lot of defects and impurities were observed, confirming deep flaws in the longitudinal direction, which is typical in spalling damage.

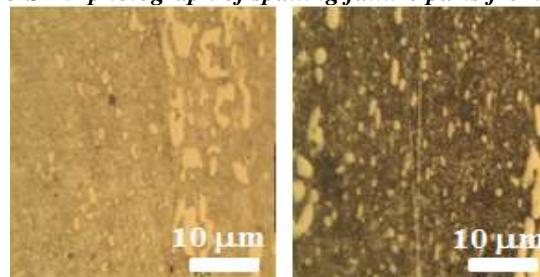
Fig. 6 Microstructure observation of spalling failure part and base metal

Fig. 6 shows the structure in the base material with and without damage. Generally, toughness is lost by quenching and regained by tempering. The base material formed a tempered-martensite structure with high strength and toughness, but the the damaged part shows a somewhat coarser spheroidizing structure. Therefore, the material was changed from a martensite structure to a spheroidizing structure with degradation. Due to the spheroidizing structure, peeling occurs easily with an external impact.

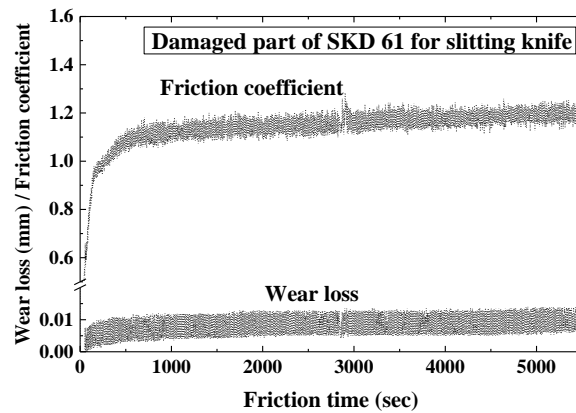
Fig. 7 Wear loss and friction coefficient according to friction time

A wear test was conducted on the inside (a portion close to the radius of the slitting knife), surface and damaged parts (knife edge) of the slitting knife. Fig. 7 shows the wear loss and the friction coefficient of the damaged part.

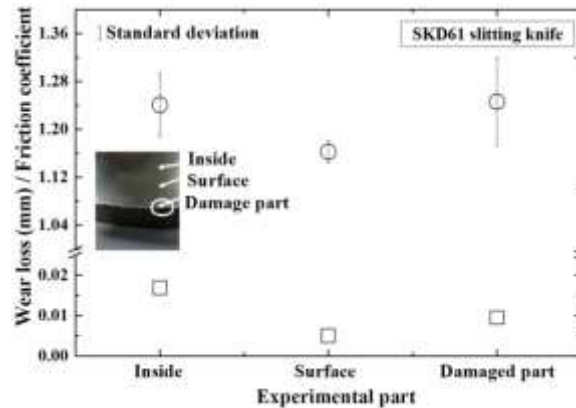
Fig. 8 Wear loss and friction coefficient according to experimental part

Fig. 8 shows the average wear loss and the average friction coefficient obtained from the three areas subjected to wear tests. Specimens became damaged as the slitting knife was used over a period of 1 year. Therefore, the friction coefficient and wear loss at the knife edge was slightly larger. The friction coefficient and wear loss of the heat-treated surface was small while the inside showed larger damage than the polished edge because of cutting. Tables 1 and 2 show the mean, standard deviation (STD), and coefficient of variation (COV) according to mathematical statistics.

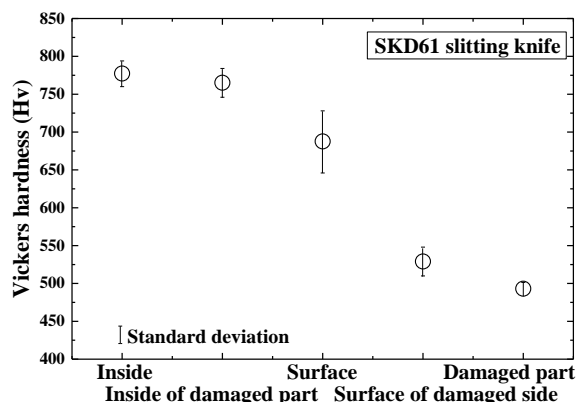
Fig. 9 Vickers hardness according to specimen conditions

Fig. 9 shows the mean Vickers hardness measured at each location. The mean value of the Vickers hardness was approximately 760 and 687 Hv on the inside and the heat treated surface, respectively. On the other hand, the corresponding values on the surface of the damaged side and the damaged part were 530Hv and 493 Hv, respectively. The damaged part showed the smallest value. This is because the peeling occurred from shock due to repetitive cutting operation.

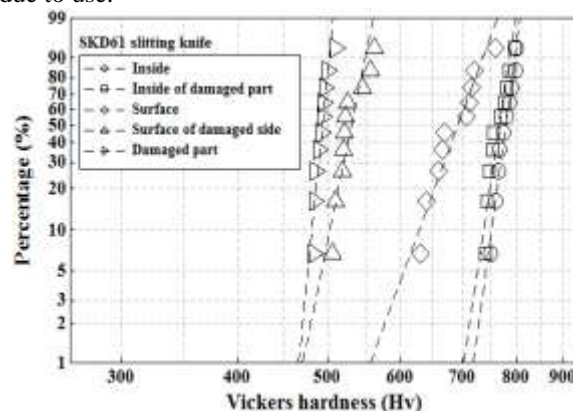
Fig. 10 Weibull plot of Vickers hardness values

Fig. 10 shows the Vickers hardness according to the Weibull probability. Since hardness is expressed as a straight line, it can be seen as applicable to the Weibull probability distribution. The Vickers hardness of the damaged specimens (Δ , \triangleright) was significantly lower than that of the inside specimens (\circ , \square). The value for the surface specimen (\diamond) was higher than for the damaged specimen (Δ , \triangleright), but was lower than for the inside specimen (\circ , \square). This is caused by degradation due to use.
