ABSTRACT

Plant load is continuously increasing and therefore turbine load is also increasing. In case of condensing cum extraction type of turbine it becomes very tuff to analyze and find the root cause of problem because there are so many interlocks. This case is classical example of a SYN gas compressor turbine. Turbine model is –ENHK-40/40-3.

Singh, D., & Tembhurne, Y., Ass. Prof. (n.d.). PROBLEM OF HIGH FLUCTUATION IN SPEED DUE TO REDUCTION IN EXTRACTION STEAM FLOW. *INTERNATIONAL JOURNAL OF ENGINEERING SCIENCES & RESEARCH TECHNOLOGY*, 7(3), 315-322.

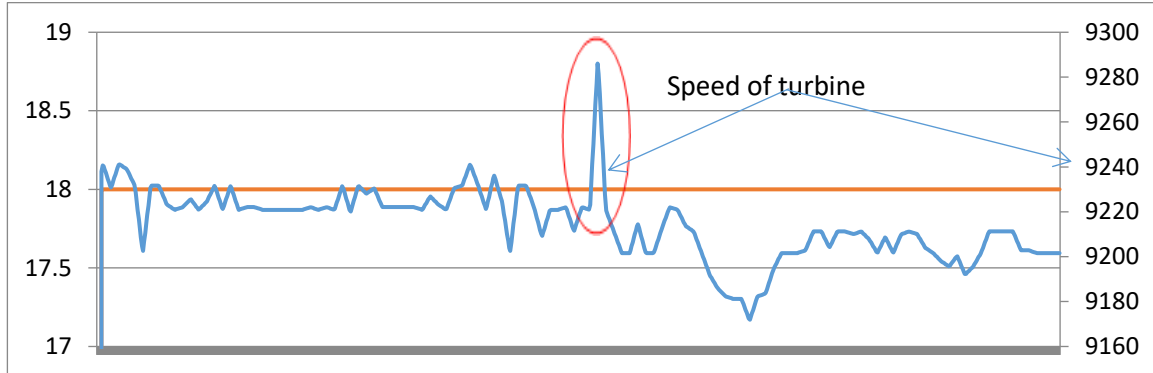
As shown in graph speed (Blue line) have taken sudden jump in graph, change in speed is around 80 RPM as per graph but in real it is of 200RPM (due to average value of 4 second it is less in graph). While no change in speed command given to governor by any signal. This new type of problem is faced in extraction cum condensing turbine. On 17th nov17 plant is also forced to trip on the same condition, we observe that turbine speed suddenly came down to 1000 rpm and turbine could not retain the speed again data is as per below detail

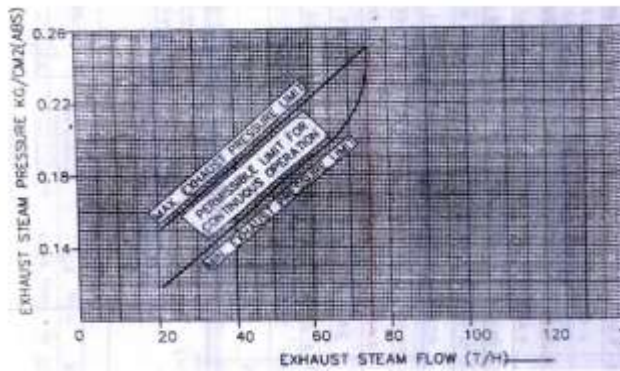
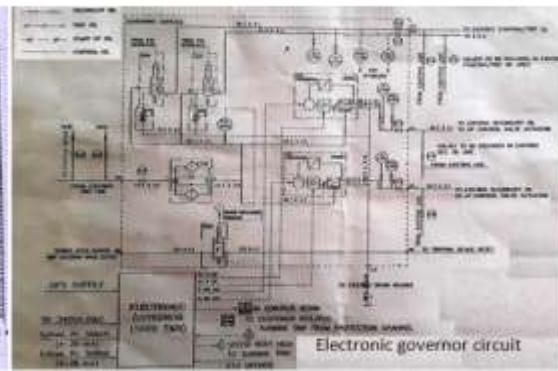
From above table we find that in past, turbine was run at more condensing load (72T/H) but at present above 66T/H flow of condensing steam turbine starts hunting of approx 100-200RPM. So we again check maximum design condensing flow by below curve(supplied by Manufacturer), which clearly states that we can go up to 75ton condensing load.

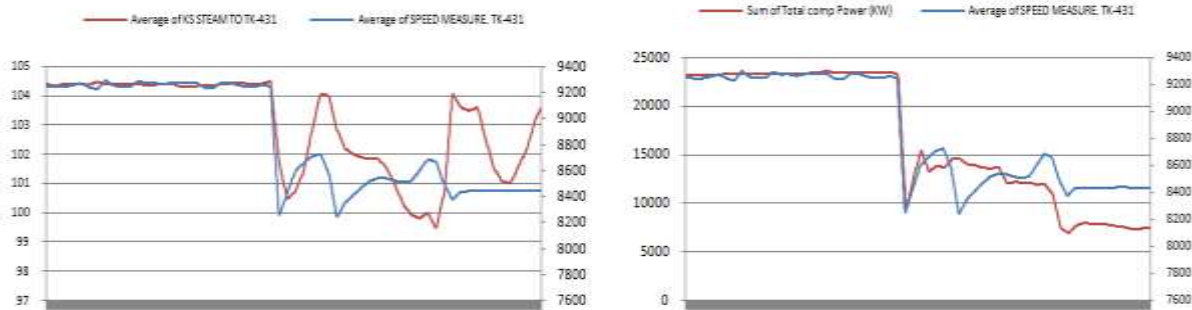
Current running graphs

It is clearly visible from above and below curve that after a certain condensing load this phenomenon occurs. In this case when we tried to increase the condensing load above 66T/H the speed fluctuation appeared and LP control valve started oscillating .

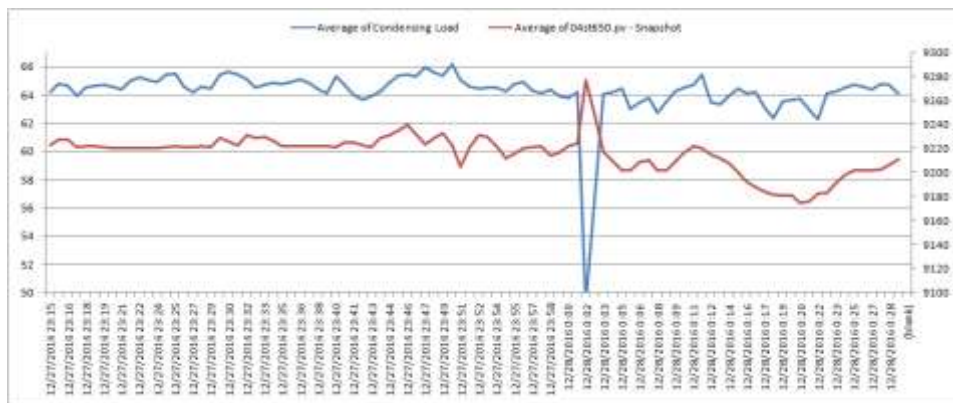
From exhaust curve we noticed that turbine was below design limit and also from HP & LP valve characteristic curve we notice that turbine governor is map up to 75T/h exhaust load.

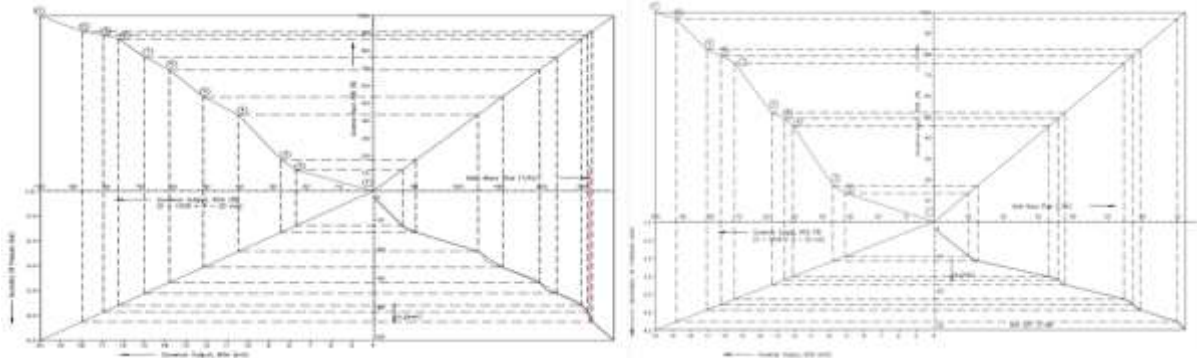
From above we also notice that all the parameters are within range. Power of turbine and speed are directly link so we go through power calculation of turbine, Turbine is divided in to two part HP and LP from both the section power is generated. In HP section power is generated by KS steam and in LP section power is developed by HS(42kg/cm²) steam. Power ratio developed by steam in both the section *KS steam-105kg/cm² at 550°C & HS steam-41kg/cm² at 350°C

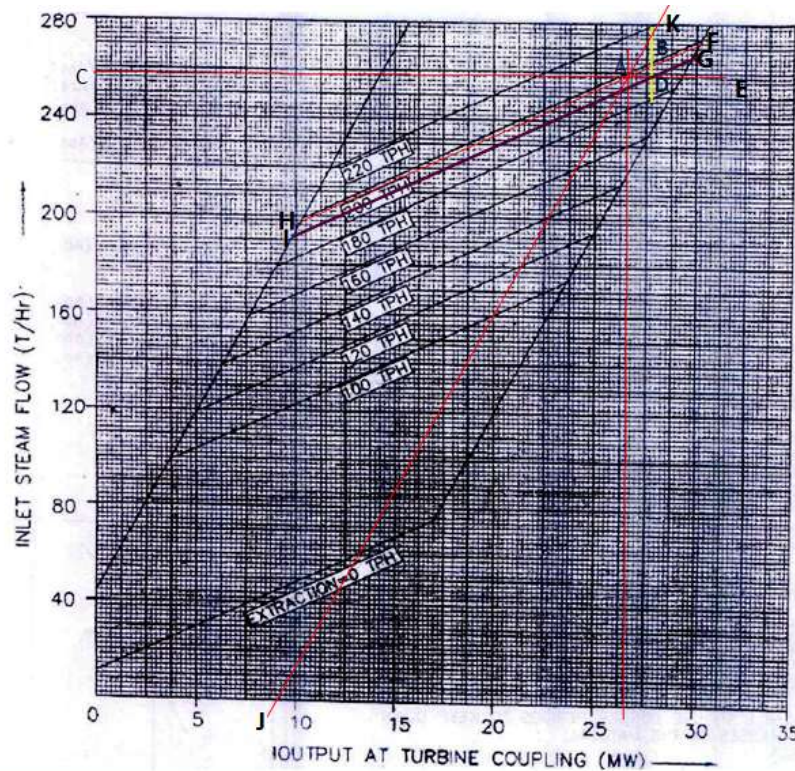
But problem is why speed hunting in decreasing the extraction steam flow, for identifying the problem we go through below steam flow Vs power curve (supplied by OEM) and draw following

Restriction in condensing flow= 6 T/H (72(designed/ previously achieved)-66(existing max flow))

Reduction in power= $\eta Q \cdot h = 0.6 \cdot 6000 / 3600 \cdot 3157.52 \text{ KJ/kg} = 3157 \text{ KJ/s} = 3.1 \text{ MW}$ (taking turbine LP stage efficiency 60%)

Drawing line JK for this flow reduction of 3MW which is passing from point A so if we cross point A, power will not developed by turbine and governor will not take action as per current condition first it will reduce the extraction steam but due to not developing of power by LP section, speed will drop and so it will increase KS flow for maintaining the speed but since the extraction steam is restricting by command and condensing path chocking governor was starting malfunctioning and results in speed hunting.
