International Journal of Engineering Sciences & Research Technology

KEYWORDS: Centrifugal Pump, Accelerated Life Test, Pump Performance, Life Time, Reliability, Nuclear Power Plant.

This paper describes that for the purpose of ensuring the reliability of the centrifugal pump such as verifying of performance degradation due to long term operation and predicting the time of failure occurrence, an acceleration test device was developed and used in an acceleration test to experimentally evaluate the pump's performance changes according to increasing of its operation time.

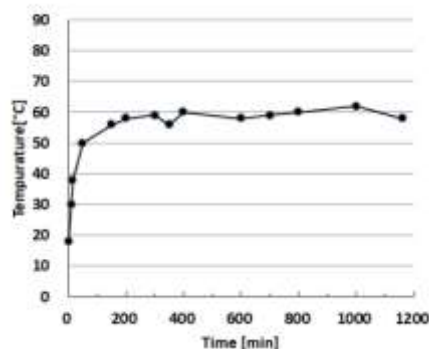
Fig.4 Pump bearing temperature curve

The bearing temperature, which was room temperature in the initial stage, increases rapidly as the pump starts to operate, but it can be observed that the equilibrium state is reached within a short time due to heat transfer to the outside atmosphere. At this point, by maintaining about 60 °C, it can be confirmed that the temperature is lower than the reference temperature (75 °C, see Table 3) suggested by the Korea Industrial Standard (KS B 6301).

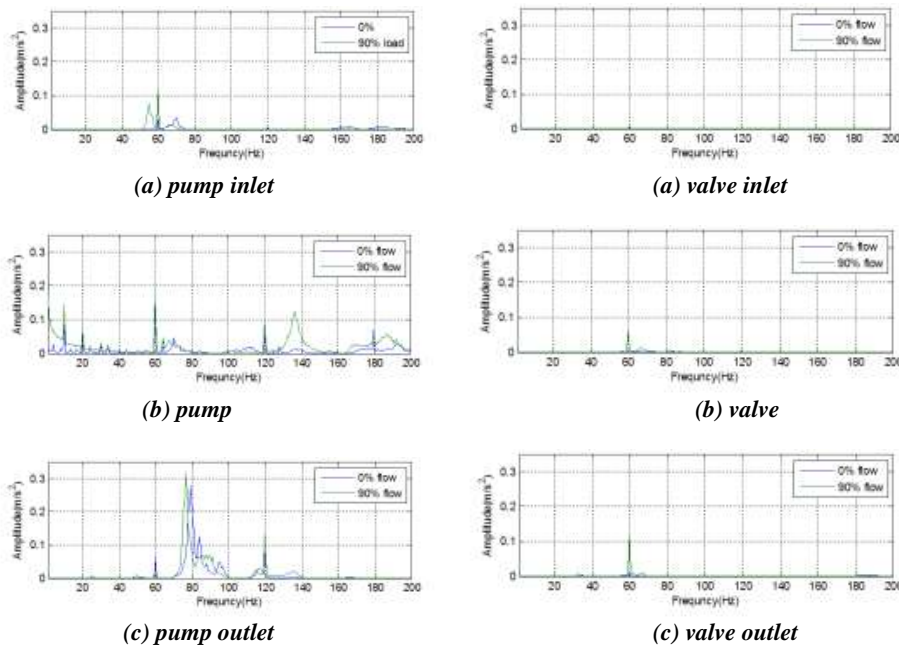
Fig.7 Results of FFT analysis at pump side Fig.8 Results of FFT analysis at valve side

From Figure 7 and 8, it can be confirmed that the 60Hz vibration due to the motor RPM (3600RPM) occurred most extremely in the pump(s) that mainly caused excitation. Also, in the case of vibration characteristics in the vicinity of the pump, some vibration characteristics at frequencies such as 120 Hz, 180 Hz derived from the rotational frequency of 60 Hz was observed. The vibration characteristics in the pipe connected to the pumps, however, can be seen that most of the vibration of the main excitation frequency 60 Hz is transmitted.

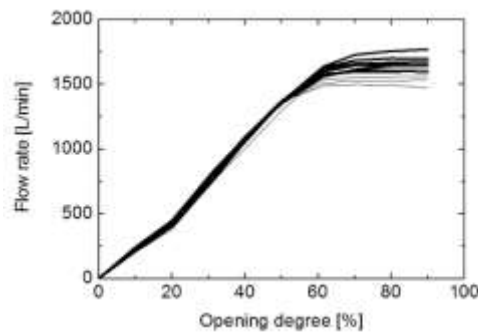
Fig.9 Flow rate by valve opening degree

Figure 9 shows the change of the pump flow rate by the pump acceleration test in terms of the valve opening. The change in flow characteristics according to increasing accelerated operation time indicates that the valve opening degree is set low so that the influence of the acceleration test is not significant in the operating conditions where the flow rate through the pump is small. On the other hand, in the operating conditions where the valve opening degree is set high and the flow rate through the pump is large, the flow rate decreases as the operation time by the acceleration test increases.

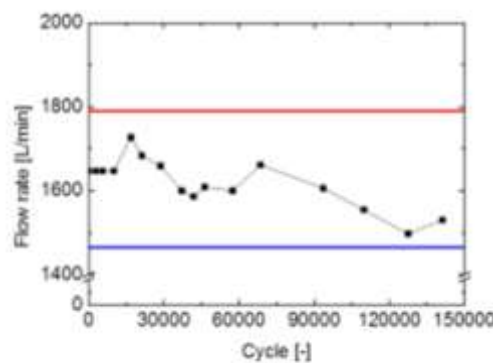
Fig.10 Flow rate at pump design point(Valve opening degree 61.5%)

Figure 10 shows the change in flow rate at the valve opening (61.5%) corresponding to the pump design point flow rate. The solid lines (upper limit: red, lower limit: blue) in the figure indicates the criteria of the pump flow rate limit of KEPIC MOB 5200. From the figure, it can be seen that the flow rate decreases as the operation time by the acceleration test increases. In the repetitive operation range applied to this paper, although the acceptance criteria of the KEPIC were met, the flow rate through the pump gradually decreased and approached the lower limit even though the same load was applied.

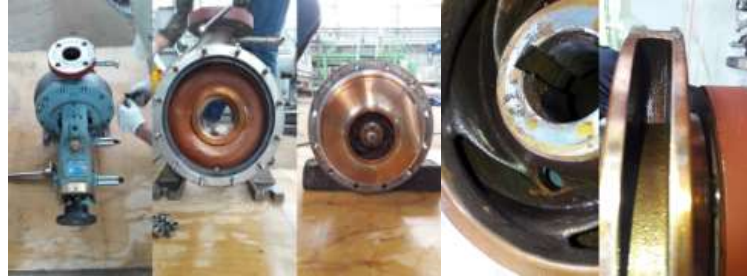
(a) casing (b) impeller
 Fig.11 Inspection after pump test

Figure 11 shows the picture of the disassembled pumps. As a result of the post-disassembly inspection, residues adhered to the pump casing were found, and SEM-EDS was performed to confirm the cause. The result is described in Table 4. According to the analysis results, it is determined that the unfiltered sludge such as beryllium (Be) and iron (Fe) derived from the use of industrial water, or the corrosion due to the carbon steel pipe adhered to the casing wall inside the pump. Also, it was confirmed that the interference between the impeller (a rotating part) and the casing (a non-rotating part) occurred so that some scratches on the wall and some looseness and spacing occurred. There was, however, no breakage or obvious deformation of the impeller or major components.

Through the pump disassembly inspection in the previous section, it was confirmed that there was no issue in the impeller wear/damage.

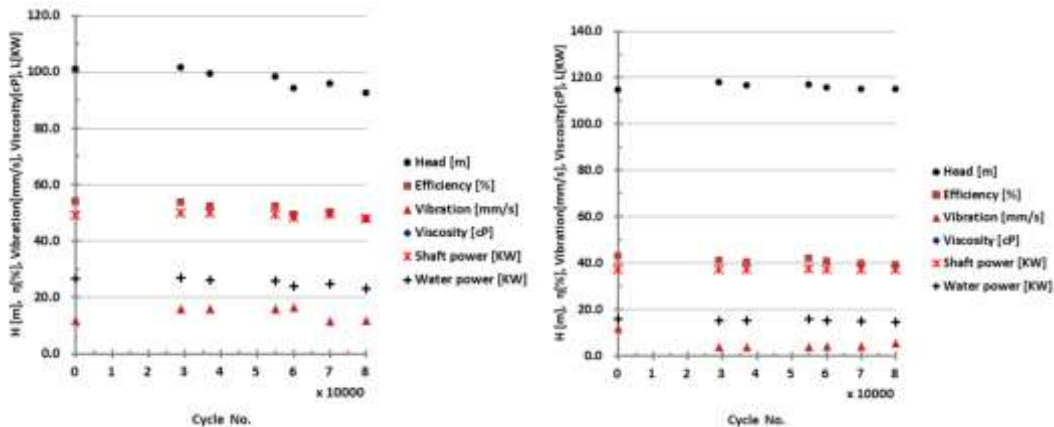
(a) at Q=100% (b) at Q=50%
 Fig.12 Pump performance

Figure 12 shows the change in the pump head (H), efficiency, vibration, lubricating oil viscosity, axial power, and hydraulic power at the pump design point flow rate (Q = 100%) and 1/2 of the design point flow rate (Q = 50%). As shown in the figure, each performance parameter decreases (decreases in performance) as the operation time increases (the number of acceleration cycles increases). First, the pump head (H) is larger at Q = 100% than Q = 50%. Besides, when comparing the hydraulic power and the axial power, the decrease of the former is slightly larger than the latter, and this caused the efficiency decrease. In addition to this, it is determined that the decrease in the pump head mainly caused the efficiency decrease.

The main causes of the decrease of the pump head (H) at the same RPM, flow rate, and axial power conditions include impeller wear/damage, gaps between the impeller and the casing, and problems with the flow itself (cavitation).

The pump head decrease is more prominent at the design point Q = 100% than Q = 50%, and the vibration is also greater at Q = 100%. The velocity of flow is faster at Q = 100% than Q = 50%, and thus the static pressure is relatively low and cavitation may affect it. There is no change, however, in the net positive suction head as the operating time increases, so the direct relationship with the development/expansion of cavitation is not clear.

Namely, the decrease of the pump head is considered as gap problem between the impeller and the casing, so to maintain the pump performance, it is very important to keep the looseness and the gap normal between the impeller and the casing through periodic maintenance.
