**INTERNATIONAL JOURNAL OF ENGINEERING SCIENCES & RESEARCH
TECHNOLOGY**

**INVESTIGATION INTO THE REASONS BEHIND PANEL FAILURE IN THE
DURBAN CONTAINER TERMINAL – PIER 2**

Rowen Naicker*, Dhiren Allopi

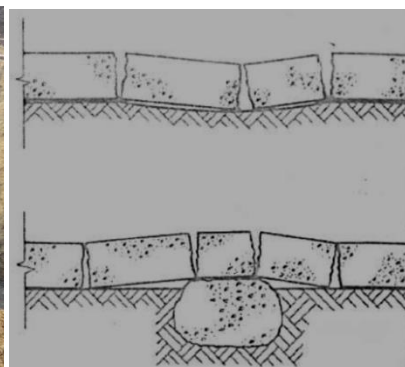
It was noticed that unfitting backfill material (figure 15) was used in some areas in Pier 2. This resulted in hard and soft spots (figure 16) being formed in the vicinity in which there were vast amounts of panel failure. Serious panel failure resulted due to the fact that this material lacked compaction and subgrade uniformity.

Figure 16: Hard and soft spots

The unsuitable material should be removed and replaced with imported G10 and thereafter be completed with 150mm of G5 and G2 up to the underside of the slab. After compaction of each of these layers density tests should be carried out progressively. Density tests should be done at least every 300mm on the G10 depending on the depth of the backfill.
