International Journal of Engineering Sciences & Research Technology

(A Peer Reviewed Online Journal)
Impact Factor: 5.164

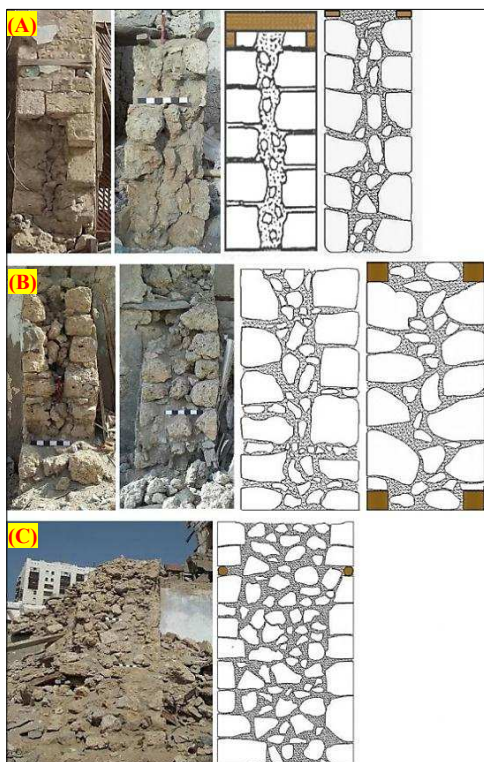
Figure 2: Examples of the major types of the multiple-leaf stone masonry walls of the heritage buildings at Historic Jeddah; (A) small thickness (0.45-0.55 m); (B) medium thickness (0.6-0.8 m); (C) large thickness (> 1 m).

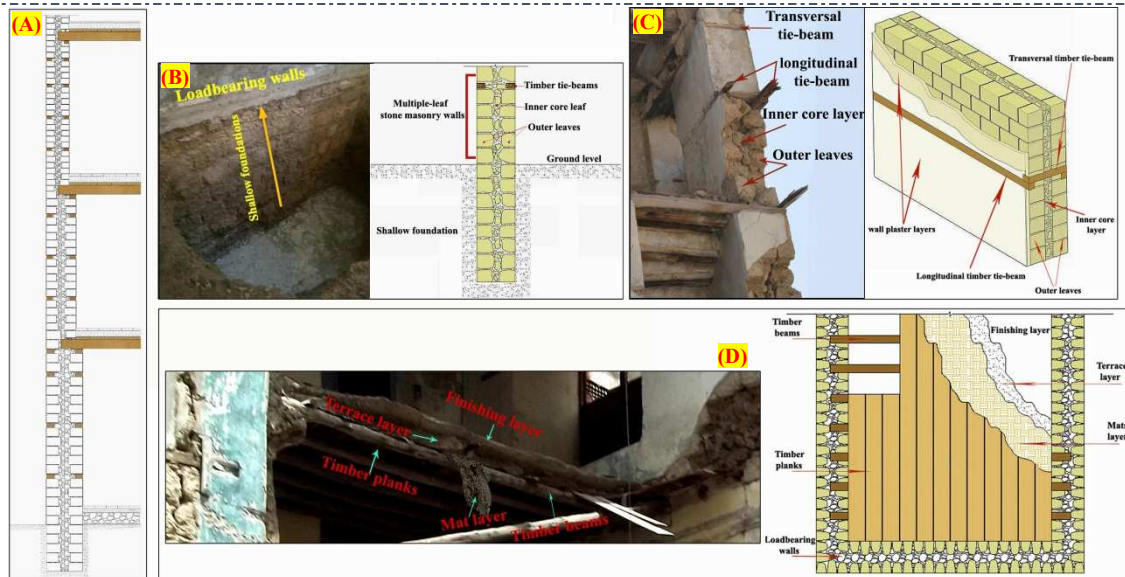
Figure 4: Construction details of Jeddah heritage buildings; (A) Sketch drawing of the external wall cross-sectional view shows that the wall thickness reduced at each floor level, (B) Photo and cross-sectional view of the wall foundation, (C) Photo and 3D-model of stone masonry loadbearing walls and their components, (D) Photo and plan view of the predominant traditional roof.

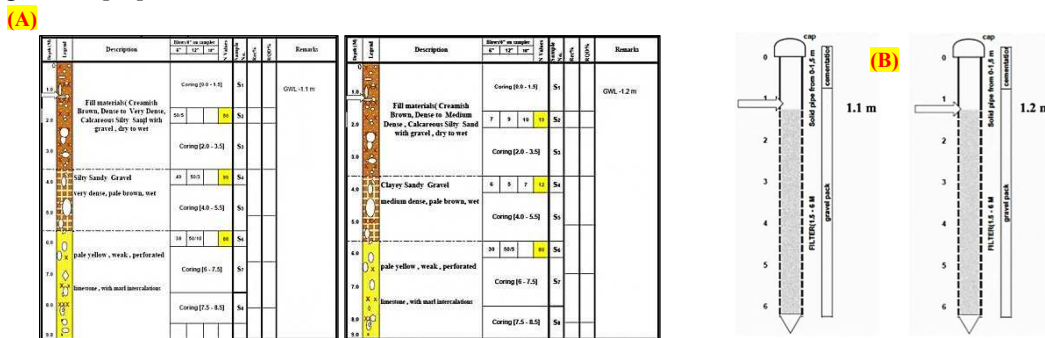
Figure 5: (A) The logs of boreholes that were drilled in one of the heritage buildings in Historic Jeddah (Xenel house), show detailed information and data about the soil stratification; (B) Result of monitoring the underground water table during drilling, shows a high level of groundwater, inferred level of groundwater which was (1.1m to 1.2 m).

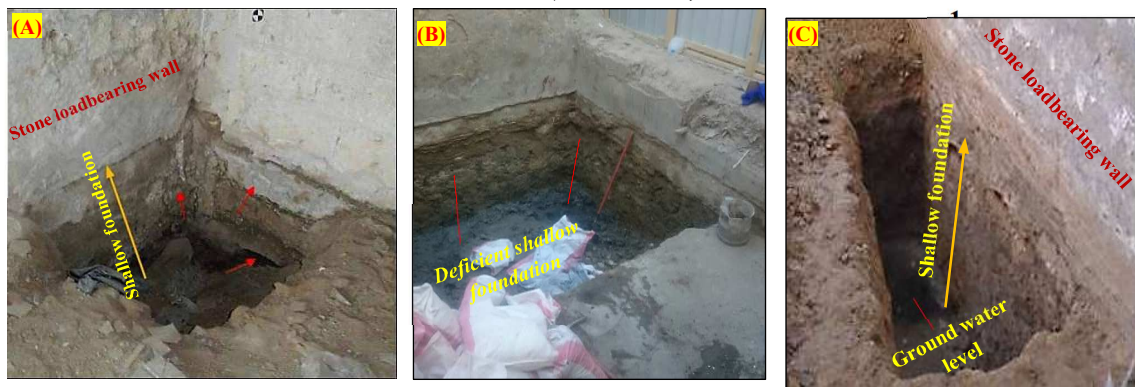
Figure 6: (A, B) Illustrate the vulnerability of the structural state of the shallow foundations of heritage buildings in historic Jeddah; (C) shows the ground water rise and its leakage to the foundation.

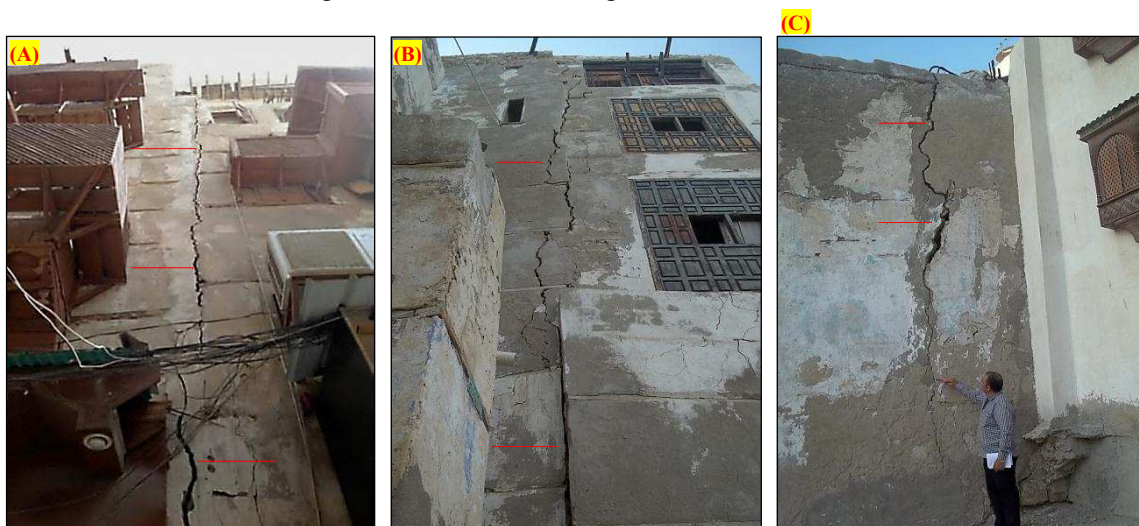
Figure. 7: Large vertical structural cracks run through the entire height of the masonry walls of some heritage buildings at historic Jeddah.

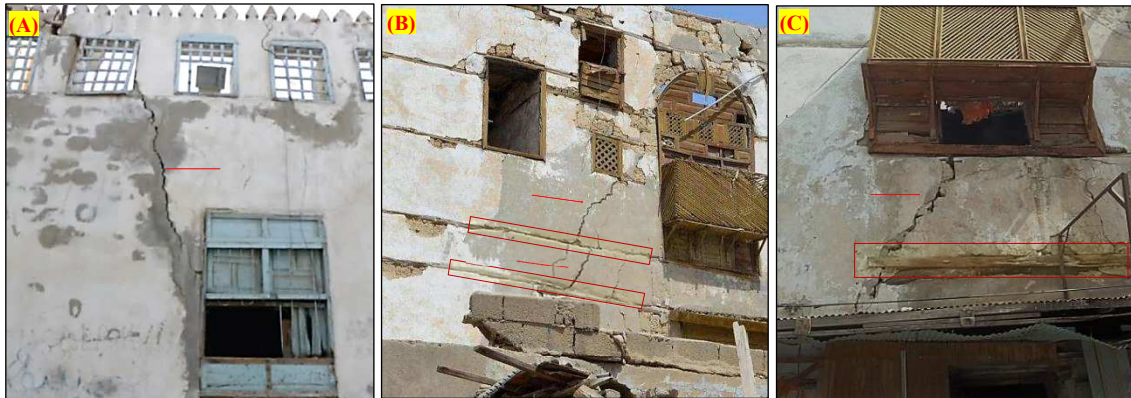
- The impact of lateral loads caused by differential settlement of foundations and bearing soil, or by the vibrations, earthquakes and wind forces.
- The impact of an increase in vertical loads which are usually non-uniformly distributed.

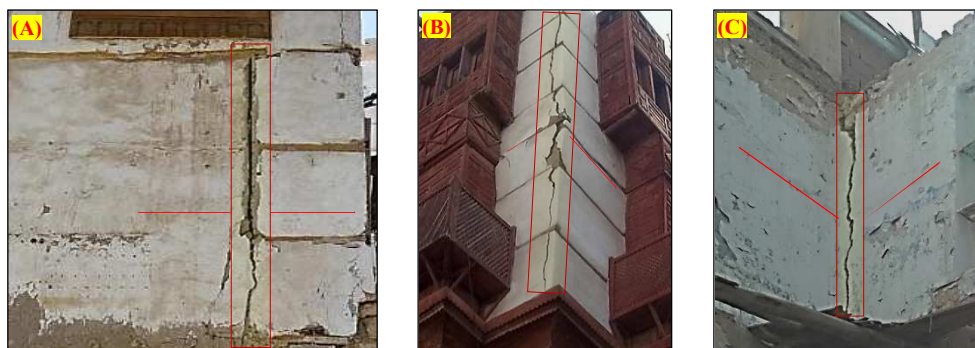
Figure. 9: Vertical separation cracks at corners; (A, B) Vertical cracking in perpendicular walls, external; (C) vertical cracking at intersecting walls, internal.

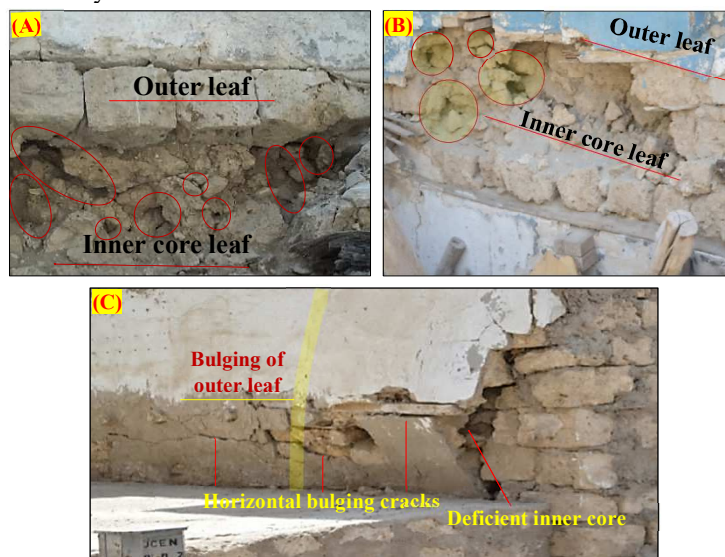
Figure. 10: (A and B) Damaged rubble infill exposed (C) Shows horizontal cracks as a result of bulging of the outer layer due to deterioration of the inner core.

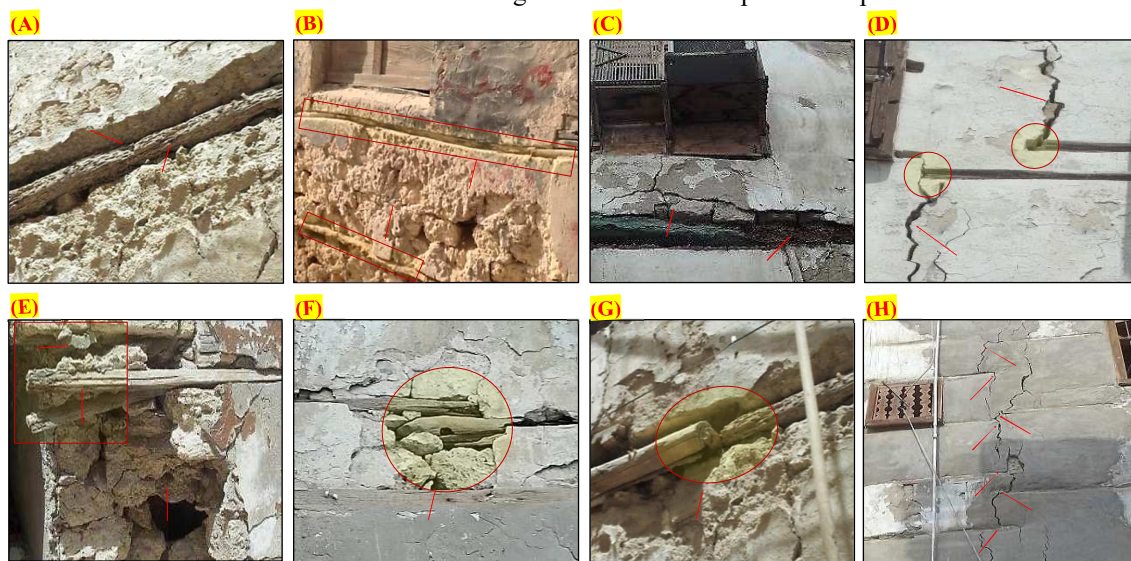
Figure. 11: Shows deterioration aspects of timber tie-beams; (A, B) The effect of high temperatures; (C) The effect of high humidity; (D) Non-extension or disconnection of timber ties; (E) inadequate connection between longitudinal and transversal timber ties; (F) the poor splicing of longitudinal timber ties; (G) lack of connection between longitudinal timber tie-beams; (H) location of poor quality connection among longitudinal timber-ties in the same location vertically.

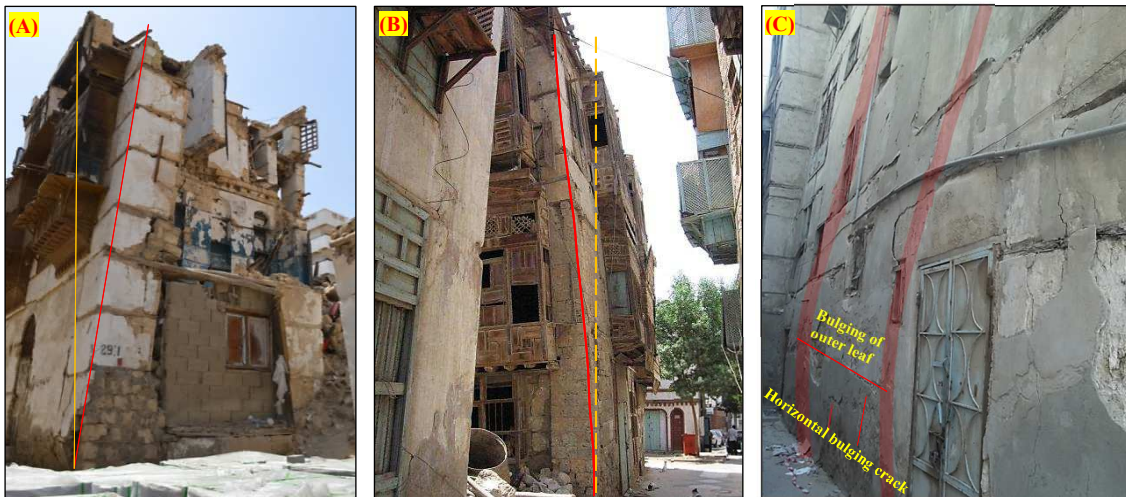
Figure. 12: Shows deformation of the masonry loadbearing walls; (A, B) Tilting of walls; (C) Bulging at the lower part of the wall.

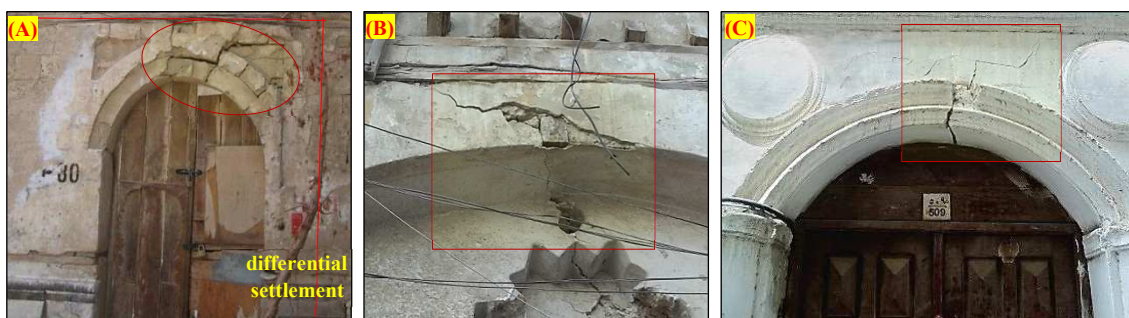
Figure. 13: Shows the deterioration and deficiency of the stone arches.

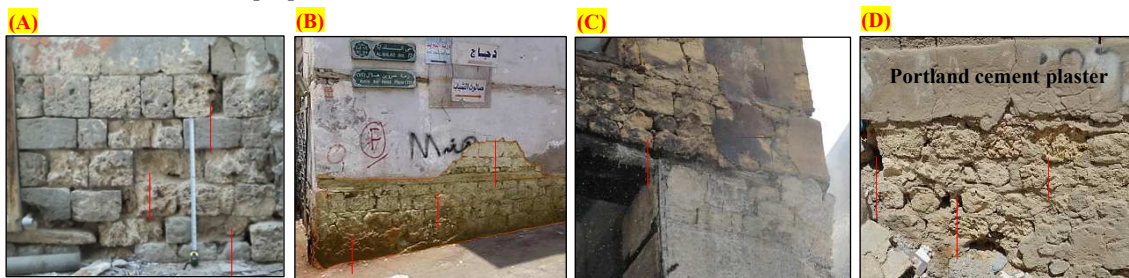
Figure. 14: Photos illustrate the weakness and deterioration of the external leaves constituent materials.

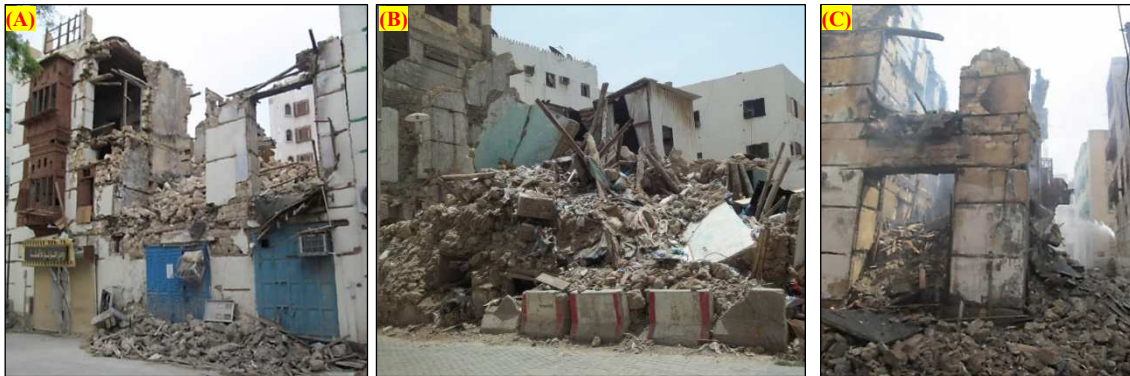
Figure. 15: Failure and collapse of some heritage buildings; (A) Partial collapse; (B): Total collapse; (C) Partial collapse caused by fires.

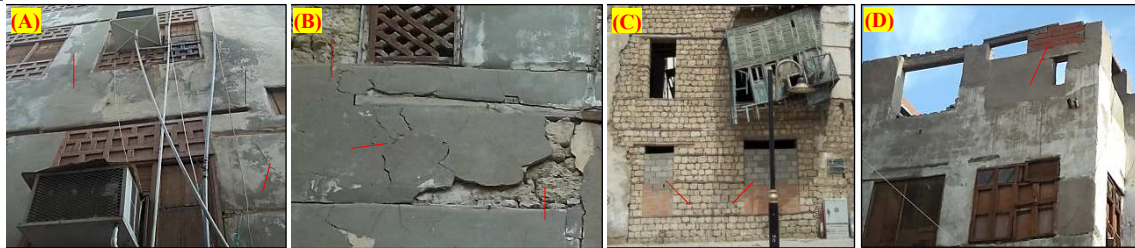
Figure. 16: Shows the effects of the use of incompatible building materials; (A, B) black cement plaster (Portland cement); (C, D) red bricks and sand crete blocks.

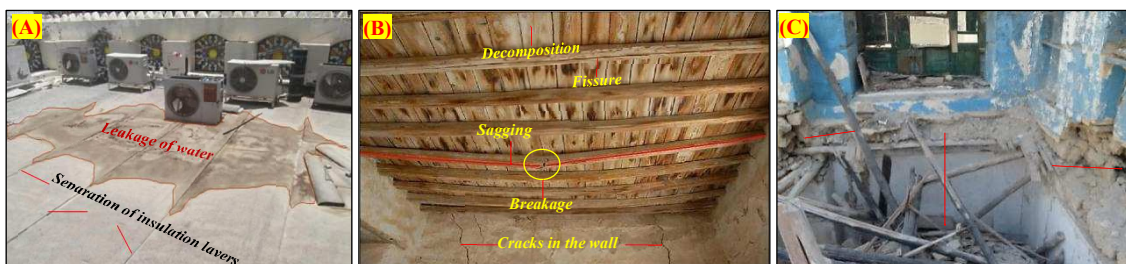
Figure. 17: Shows damage to roofs and floors; (A) Water leakage and separation of insulation layers; (B) Sagging, breakage, fissure and decomposition; (C) Total collapse.
