ABSTRACT

KEYWORDS: Disc rotor, Material, Safety, Efficiency, Design.

INTRODUCTION

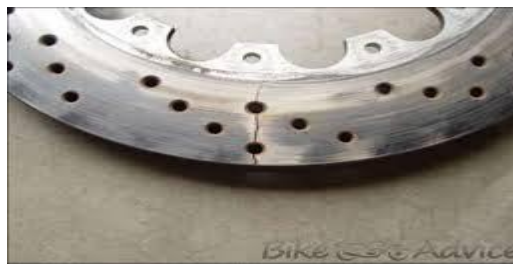
Scarring can occur if brake pads are not changed promptly when they reach the end of their service life and are considered worn out. If the scarring is deeper but not excessive, it can be repaired by machining off a layer of the disc's surface. This can only be done a limited number of times as the disc has a minimum rated safe thickness. The minimum thickness value is typically cast into the disc during manufacturing on the hub or the edge of the disc. One of the most rigorous auto safety inspection programs in North America, an automotive disc cannot pass safety inspection if any scoring is deeper than .015 inches (0.38 mm), and must be replaced if machining will reduce the disc below its minimum safe thickness.

Scarring of Disc Rotor [4]

In the Fig above, the scarring of disc rotor is shown. To prevent scarring, it is prudent to periodically inspect the brake pads for wear. A tire rotation is a logical time for inspection, since rotation must be performed regularly based on vehicle operation time and all wheels must be removed, allowing ready visual access to the brake pads. Some types of alloy wheels and brake arrangements will provide enough open space to view the pads without removing the wheel. When practical, pads that are near the wear-out point should be replaced immediately, as complete wear out leads to scarring damage and unsafe braking. Many disc brake pads will include some sort of soft steel spring or drag tab as part of the pad assembly, which is designed to start dragging on the disc when the pad is nearly worn out. The result is a moderately loud metallic squealing noise, alerting the vehicle user that service is required, and this will not normally scar the disc if the brakes are serviced promptly. A set of pads can be considered for replacement if the thickness of the pad material is the same or less than the thickness of the backing steel.

Scarring can occur if brake pads are not changed promptly when they reach the end of their service life and are considered worn out. Small hairline cracks may appear in any cross drilled metal disc due to the disc's uneven rate of expansion in severe duty environments. No repair is possible for the cracks, and if cracking becomes severe, the disc must be replaced. The disc contact area for the brake pads will be kept clean by regular use, but a vehicle that is stored for an extended period can develop significant rust in the contact area that may reduce braking power for a time until the rusted layer is worn off again. Brake squeal is really a high frequency vibration. In disc brakes, it can be caused by vibrations between the pads and rotors. Brake vibration is where a shaking motion occurs when the brakes in a car or other vehicle are deployed

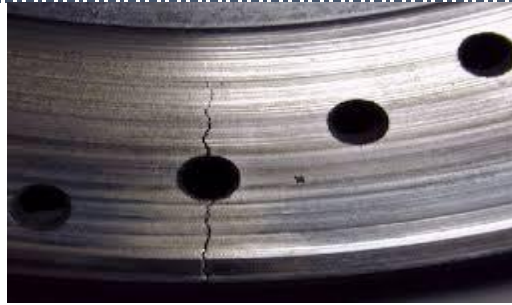
Cracking is limited mostly to drilled discs, which may develop small cracks around edges of holes drilled near the edge of the disc due to the disc's uneven rate of expansion in severe duty environments. A brake disc is a heat sink that is it absorbs unwanted heat, but the loss of heat sink mass may be balanced by increased surface area to radiate away heat. Small hairline cracks may appear in any cross drilled metal disc as a normal wear mechanism, but in the severe case the disc will fail catastrophically.

Fig. Cracking of Disc Rotor [4]

No repair is possible for the cracks, and if cracking becomes severe, the disc must be replaced. These cracks occur due to the phenomenon of low cycle fatigue as a result of repeated hard braking.

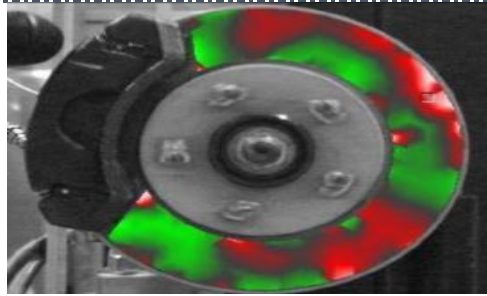
Brake squeal is really a high frequency vibration. In disc brakes, it can be caused by vibrations between the pads and rotors, the pads and calipers, or the calipers and their mounts.

Fig. Noise in Disc Rotor [5]

In the Fig. above, the noise produced by a brake rotor in a test lab has been captured electronically and converted into a color graphic. The red areas are producing the loudest noise while the green areas are producing the least noise
