**INTERNATIONAL JOURNAL OF ENGINEERING SCIENCES & RESEARCH  
TECHNOLOGY****IMPLEMENTATION OF LEAN TOOL TO REDUCE STAINS AND DAMAGES IN  
GARMENT MANUFACTURING – A CASE STUDY IN AN EXPORT ORIENTED  
UNIT****Sumalatha S <sup>\*1</sup>, Ninge Gowda K N <sup>2</sup>, Sudhakar R <sup>3</sup>**<sup>\*</sup>Department of Apparel Technology and Management, Bangalore University, India

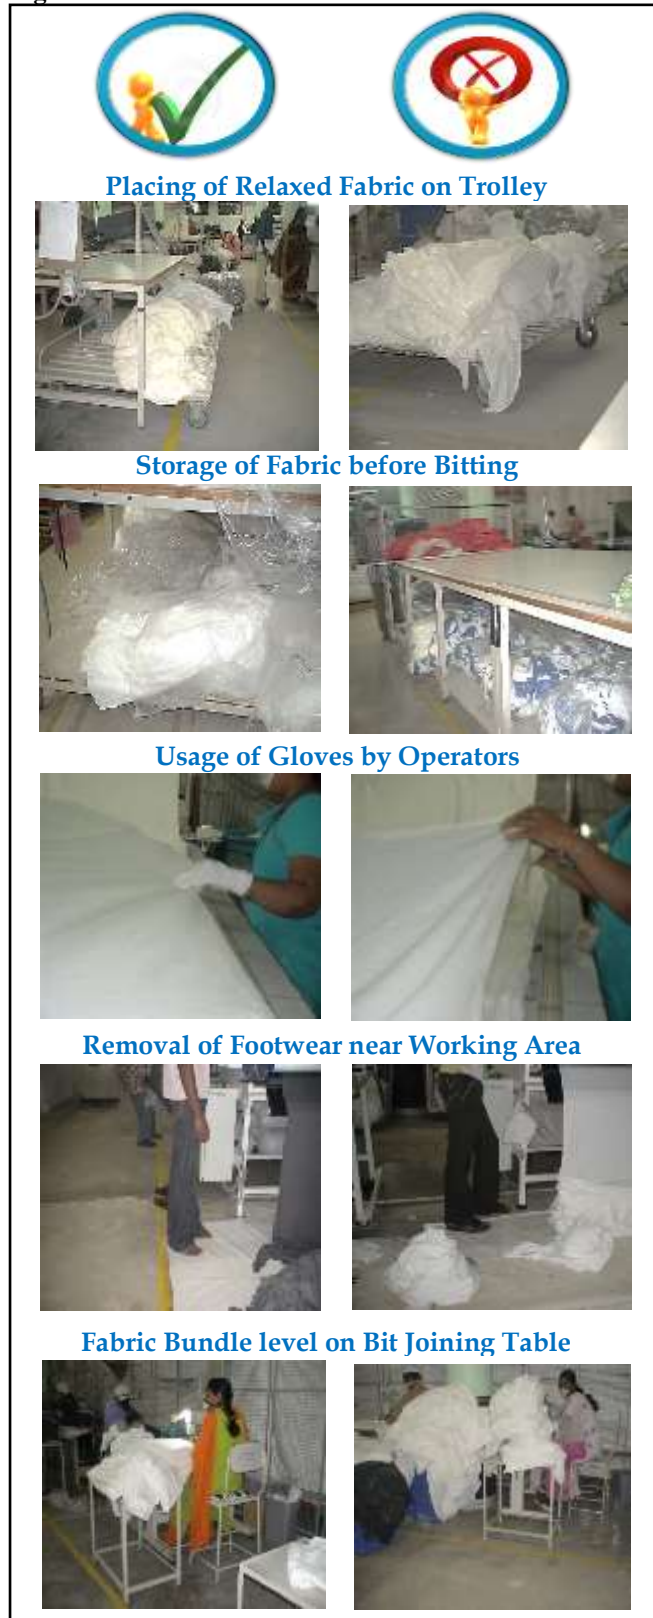
Figure 1

**Bitting Section**

Based on the observation and interaction with supervisors, dos and don'ts display charts were prepared using appropriate images. A unique story display board was prepared in which garment narrates its journey in a

garment industry. Both visual systems were displayed at most common visiting places both in bitting and washing section.

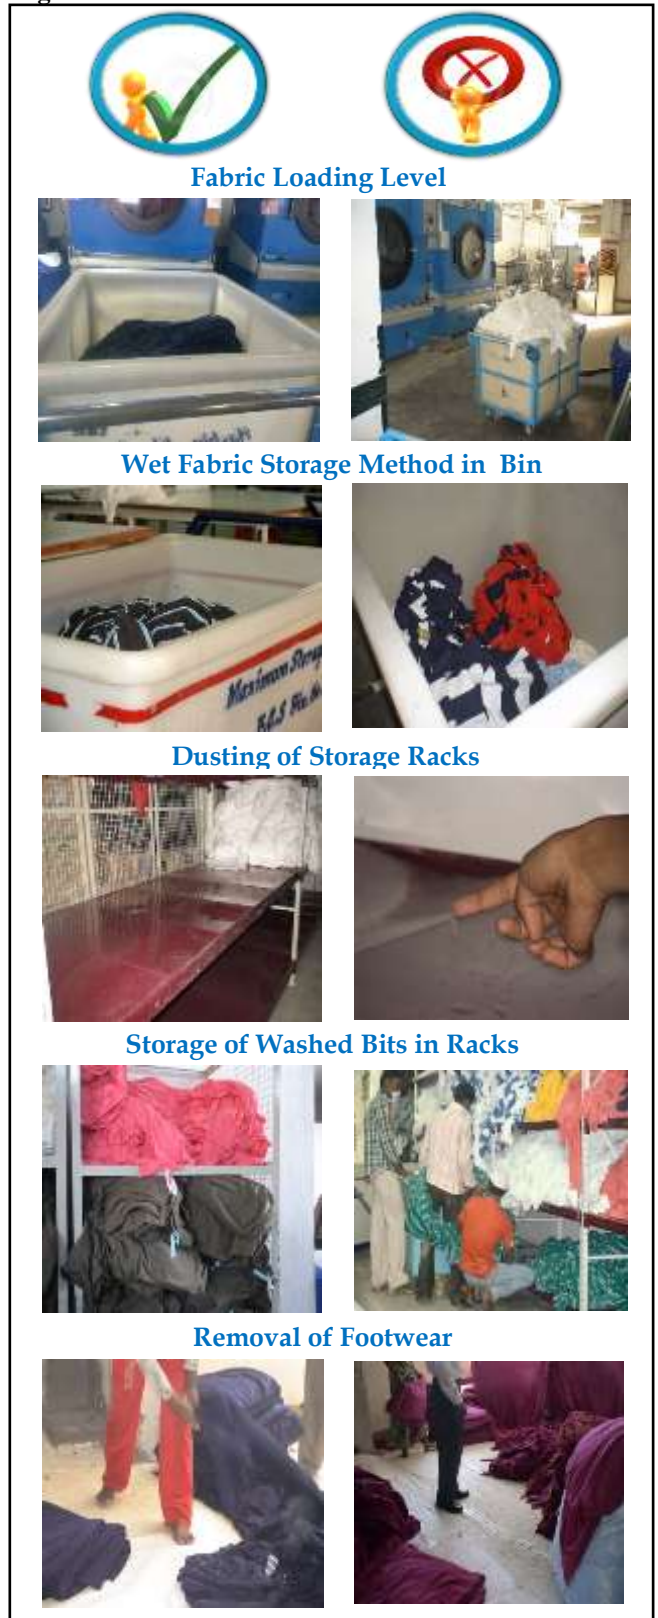
Figure 2

**Washing Section**

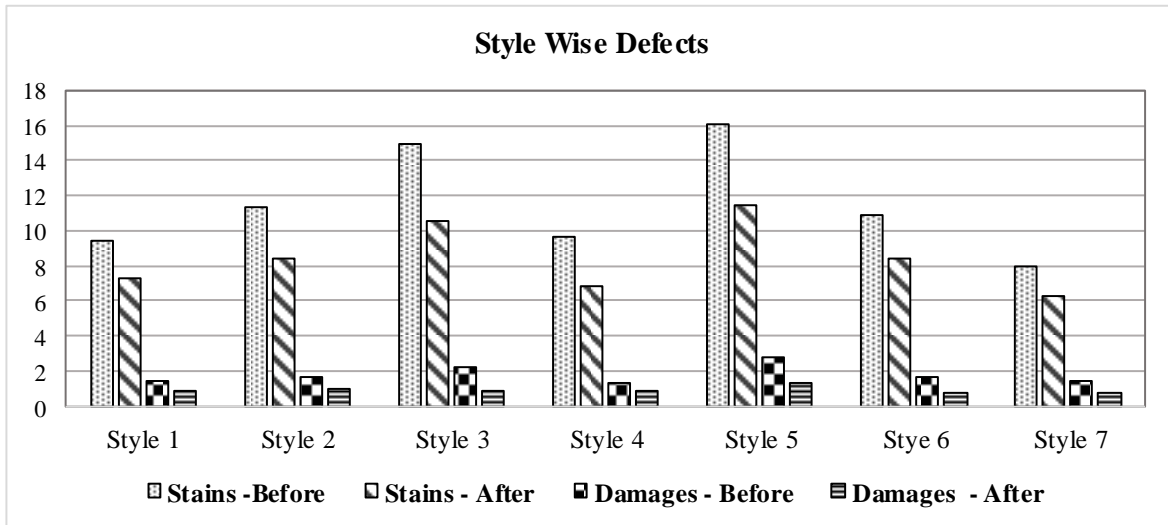
Figure 4

Style wise defects - Before and After

In figure 4 it was noticed that style 5 recorded highest stains and damages whereas style 7 being least in in stains and style 4 in damage section before implementation of lean tool. After implementation of visual tools, it was noticed that style 7 recorded highest reduction in stain and damage percentage whereas style 5 marked lowest reduction in both types of defects. The fabric colour is the prime reason for the results obtained. White colour fabrics are prone to get stained sooner and darker ones conceal light stains to some extent. Damages occur due to inappropriate lifting and placing of fabric rolls on wooden trolley and while removing label tags
