International Journal of Engineering Sciences & Research Technology

This article presents the monitoring of tectonic-coal ignition with its factor analysis with taking on-site inspection and field work measurements in the case study of the coal mine of Qianjing, Shanxi Province, China. The results show that, when nitrogen injection control measures was in a side entry of the working face, the CO-concentration in the upper corner of the working face and in the return air was remaining at a stable level, at which moment the absolute value of CO-concentration was at the level of $0.031m^3/min$. Especially when starting to weaken the equalized pressure ventilation system, the CO-concentration in the upper corner of the working face and in the return air was being lower than before, with the absolute CO-concentration at $0.029m^3/min$. The results indicate that the timely inspection, factor analysis, and prediction of tectonic-coal developing areas are effective measures to prevent the tectonic-coal ignition and CO gas emission in the case study. The study shall provide a new reference for monitoring the ignition of tectonic-coals in the similar coal mines in China or other countries.

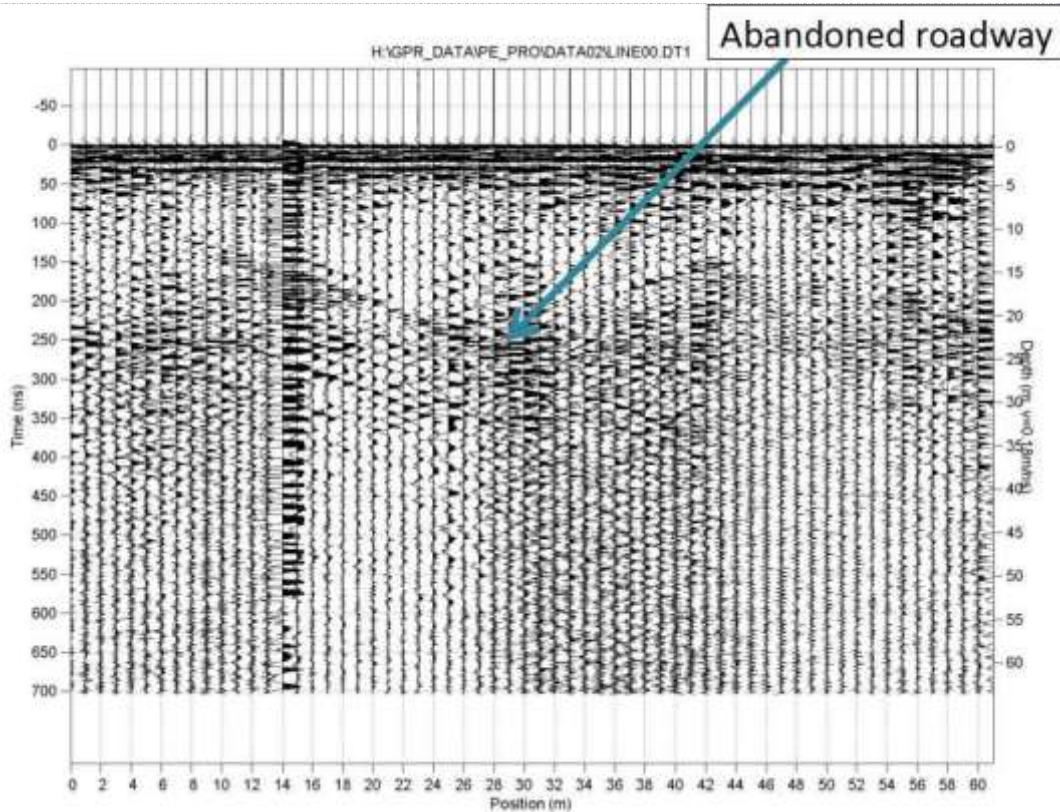
Figure 7: Tectonic coal is developed at the reverse fault of Wangping 8303 working face

- 4) Detection of gob on top of coal seam can be made by GPR (general purpose of radar shown in Figure 7);
- 5) Tectonic coal can be found at the reverse fault of the No. 8303 working face in Wangping Coal Mine (see Figure 8).

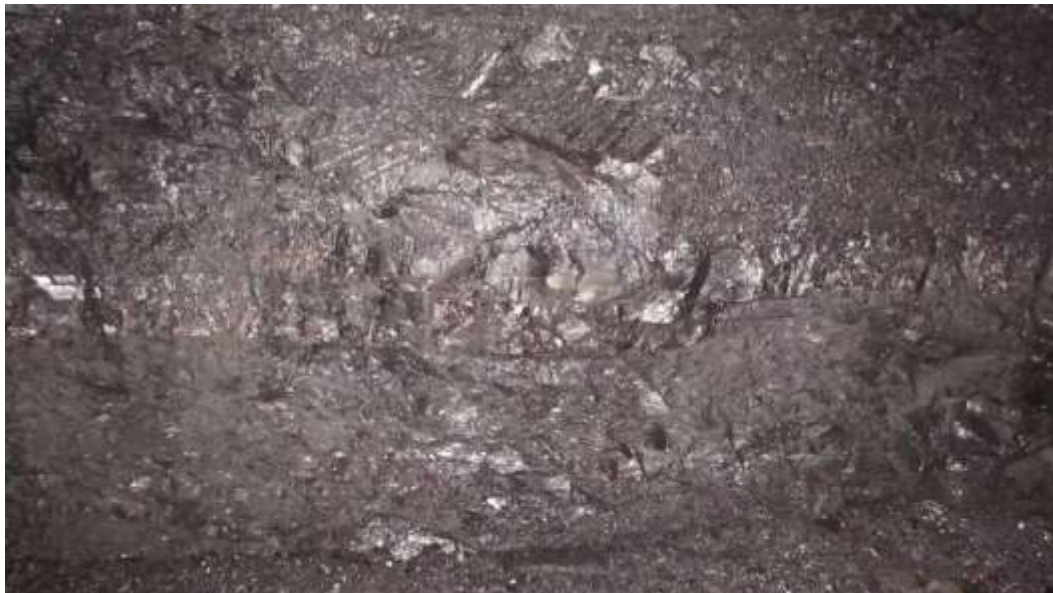
Figure 8: Tectonic coal seen at the reverse fault of the No.8303 working face in Wangping.
