## INTERNATIONAL JOURNAL OF ENGINEERING SCIENCES & RESEARCH TECHNOLOGY

### Effect of Cutting Parameters on Tool Wear of Coated Carbide Tool in Hard Turning of AISI 4340

Aman Joshi\*, Rohit Rampal

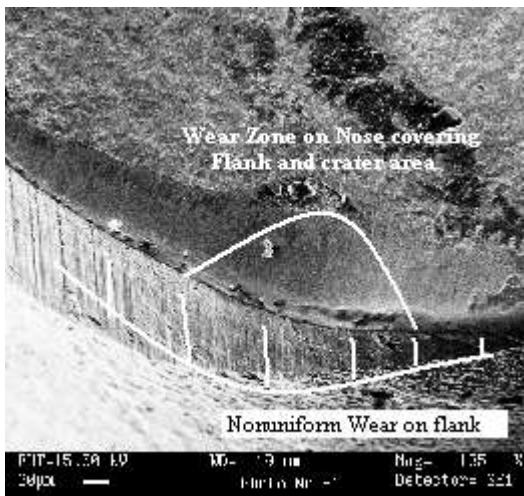
Fig.1 Coated carbide tool after 6min of machining at  $v=80m/min, f=0.08mm/rev$  and  $W.H=40HRC$

Each single pass consisted of axial cutting length 200mm and after every 100mm of workpiece length, the amount of maximum flank wear (VBmax) was recorded. The experiment was terminated when the following condition was arrived:  $VB_{max} \geq 200$  mm. Maximum tool flank wear was measured using optical microscope having image analysis software. The worn tools were also evaluated using scanning electron microscope (SEM) at regular intervals in order to understand the wear modes and mechanisms that affect the tool performance.

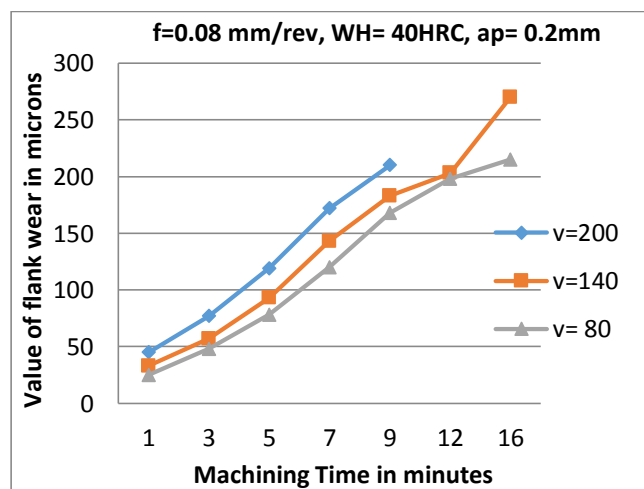
Fig.2(a) Progression of tool life at  $f=.08mm/rev, WH=40HRC$  on different cutting speeds

According to standard ISO 3685, the time at which the tool ceases to produce a workpiece of desired size and surface quality usually determines the end of useful tool life [7]. Maximum tool flank wear was measured using optical microscope having image analysis software. The worn tools were evaluated using scanning electron microscope/ microscope at regular interval in order to understand the wear modes and mechanisms that affect the tool performance. Each set of experiments replicated twice and average value of VBmax was evaluated. Progression of maximum flank wear (VBmax) with machining time in minutes at different cutting speeds and feed rates with different levels of workpiece hardness is presented in Figs. 2(a,b,c) and 4(a,b). From the graphs it is indicated that in all cases tool life is significantly affected by degree of workpiece hardness followed by cutting speed and then by feed rate [5, 6]. At low and medium cutting speed, the progression of flank wear in first few minutes of machining was gradual. In all the cases tool life of carbide inserts decreases as the cutting speed increases for all feed rates and workpiece hardness because with increase in cutting speed for a given time the cutting temperature increases, which leads to rapid tool [4, 7]. At the highest speed used the tool life was low in comparison to other two speed selected. The maximum tool life was achieved at lowest degree of workpiece hardness, because the material strength to be machined is low at low degree of hardness, which resulted in longer tool life [10]

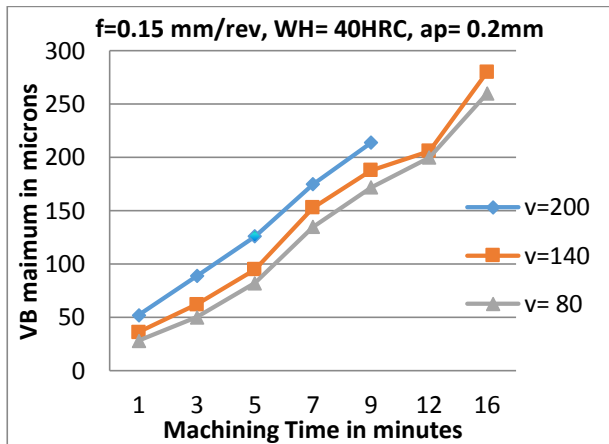
Fig.2(b) Progression of tool life at f=.15mm/rev, WH=40HRC on different cutting speeds

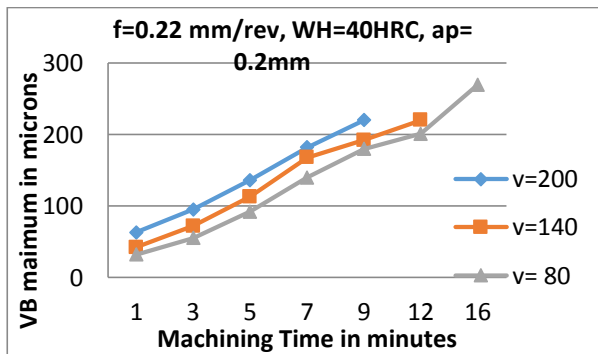
Fig.2(c) Progression of tool life at f=.22mm/rev, WH=40HRC on different cutting speeds

Under all cutting speed and hardness range used there is marginal difference between the tool life achieved at f=.08mm/rev and f=.15mm/rev, while the significant difference in tool life was observed at highest feed. The tool life is low at highest feed selected. So the study reveals that the tool life of coated carbide tools is significantly affected by work piece hardness, followed by cutting speed and then feed.

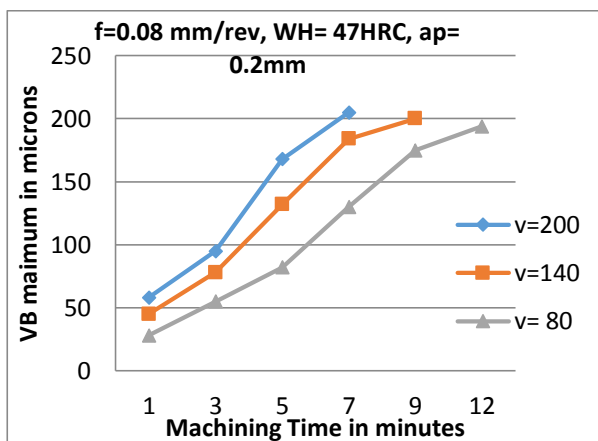
Fig.3(a) Progression of tool life at f=.08mm/rev, WH=47HRC on different cutting speeds

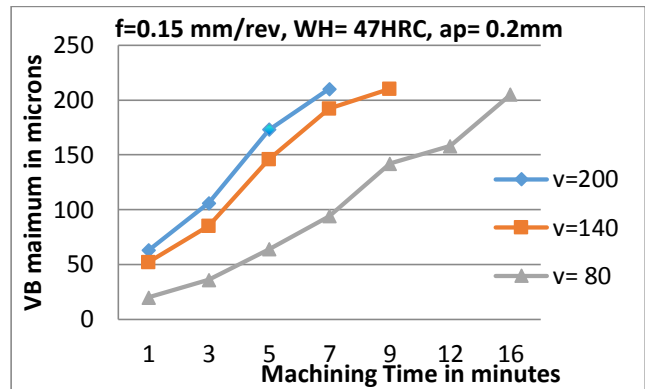
Fig.3(b) Progression of tool life at f=.15mm/rev, WH=47HRC on different cutting speeds

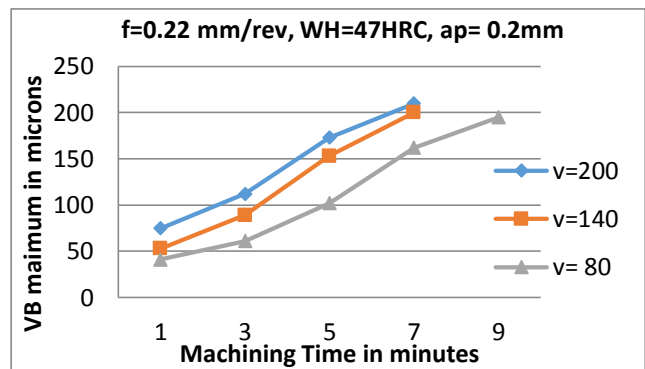
Fig.3(c) Progression of tool life at f=.22mm/rev, WH=47HRC on different cutting speeds

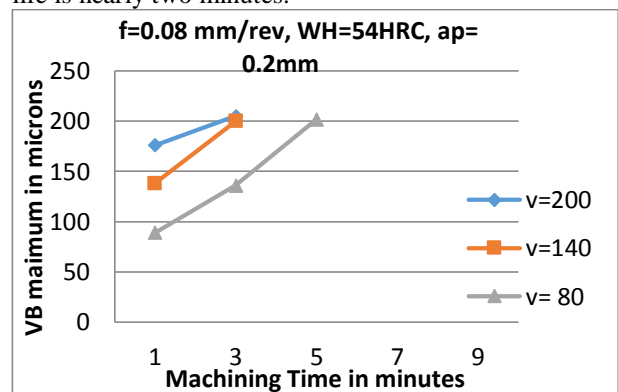
Fig.4(a) Progression of tool life at f=.08mm/rev, WH=54HRC on different cutting speeds

At highest degree of workpiece hardness, the tool life achieved under all circumstances was very short. Because at highest speed the mechanical and thermal loading led to deterioration the tool life of cutting tool. As indicated in the Fig.4(a,b) the tool life achieved under highest cutting speed with both the feed is less than two minutes. Also at other two speed used the tool life is nearly two minutes.

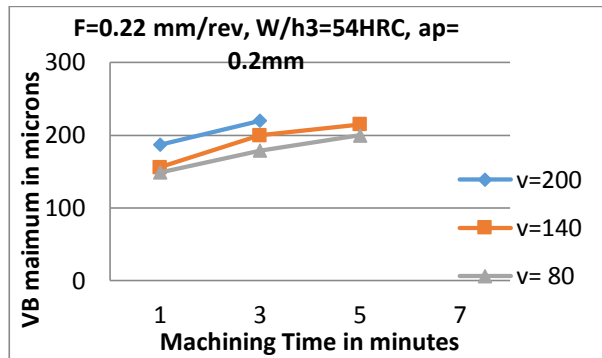
Fig.4(b) Progression of tool life at f=.22mm/rev, WH=54HRc on different cutting speeds.

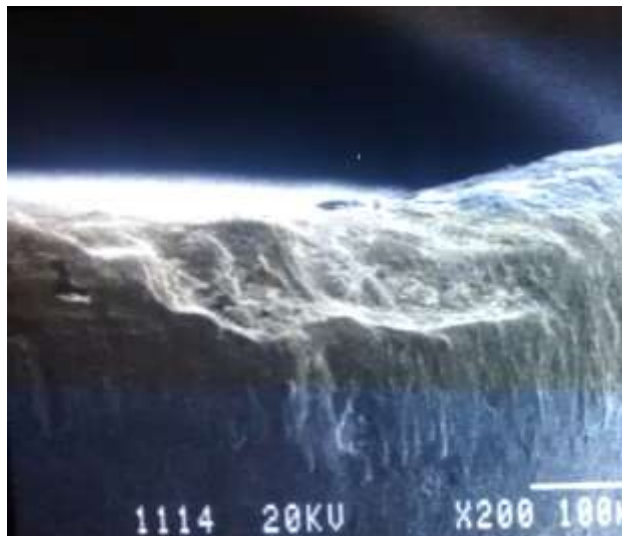
Fig.5 The cutting insert after 3minutes of machining at v=80m/min,f=.08mm/rev and W.H.=40HRc.

As shown in Fig. 5, both flank wear and crater wear were observed for both the inserts tested under all cutting conditions. The tool wear zone occurred mostly near the tool nose radius, as depth of cut selected was quite low in comparison to the nose radius of the tool [4,6]. Both crater wear and flank wear near the nose of the tool occurred during the whole machining study with both the inserts on all types of surfaces.

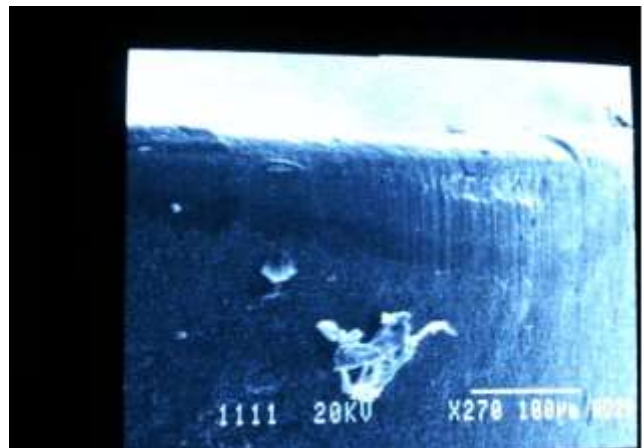
Fig.6 The cutting insert after 2minutes of machining at v=140m/min,f=.22mm/rev and W.H.=47HRc.

As shown in Figs 6 and 7, during the turning of workpiece hardness 47 HRc and 54 HRc the with carbide inserts, particularly at higher cutting speed (200 m/min), significant plastic deformation, chipping and breakage of cutting edge was observed. This kind of rapid tool wear with chipping/fracture was due to the high temperature generated and high mechanical loading on the tool edge during cutting. Failure of the tool edge started with propagation of cracks at higher speed [6,10].

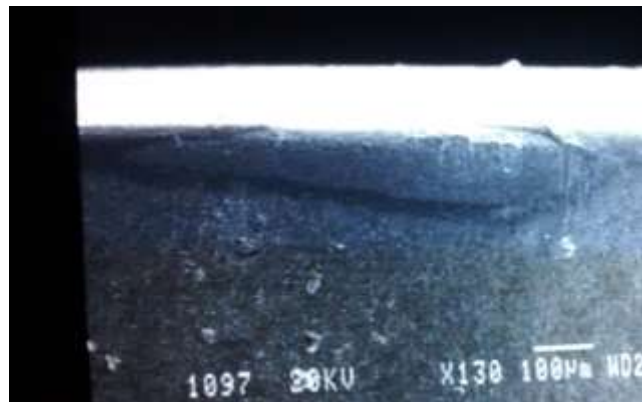
Fig.7 Edge Chipping of insert at v=200m/min, f=.22mm/rev and W.H.=54HRc

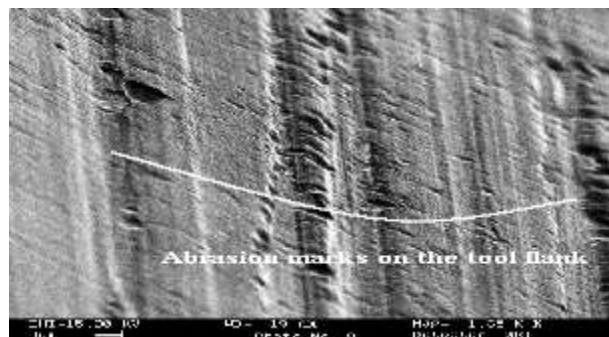
**Fig.8** The cutting insert after 2minutes of machining at  $v=80\text{m/min}$ ,  $f=.15\text{mm/rev}$  and  $W.H.=47\text{HRc}$

During turning at 80 m/ min cutting speed, abrasive marks were observed on the flank face as shown in Fig. 8, which occurred due to rubbing of hard carbides in the workpiece material on the tool edge [4, 6].

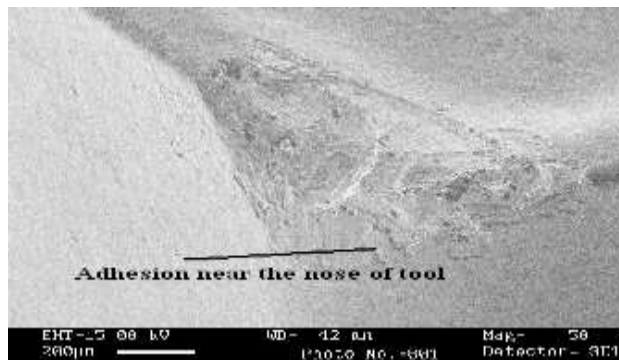
**Fig.9** The cutting insert after 3minutes of machining at  $v=140\text{m/min}$ ,  $f=.15\text{mm/rev}$  and  $W.H.=47\text{HRc}$

As shown in Fig.9, adhesion followed by plastic deformation was observed at 140 m/min cutting speeds during turning of the continuous surface. Due to increase in the cutting speed, the temperature at the work tool interface increased, which promoted adhesion wear [11,12]

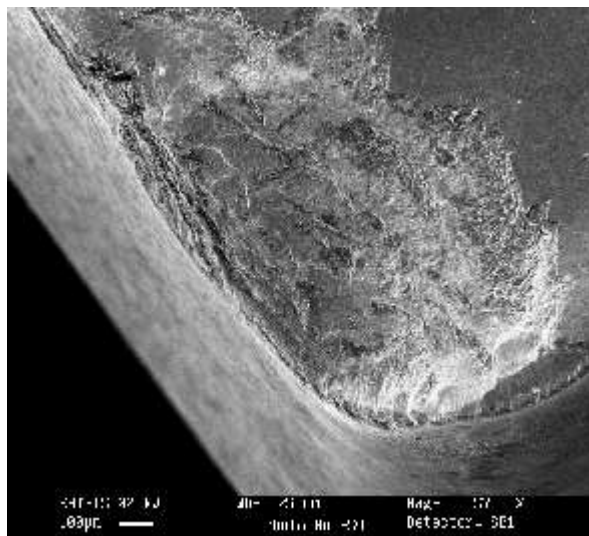
**Fig.10** The cutting insert after 1minutes of machining at  $v=200\text{m/min}$ ,  $f=.22\text{mm/rev}$  and  $W.H.=54\text{HRc}$

Significant crater wear was also observed in particular at highest cutting speed, this is mainly due to removal of wear resistant coating from the surface [10]. The main wear mechanism involved with carbide inserts was abrasion and adhesion followed by plastic deformation at low to medium speed. On the other hand, rapid tool

wear with chipping/breakage of the tool edge was observed at higher cutting speeds, which led to the end of tool life.
