**INTERNATIONAL JOURNAL OF ENGINEERING SCIENCES & RESEARCH
TECHNOLOGY**

**STRUCTURAL HEALTH MONITORING OF A CONCRETE STRUCTURES IN
GAUTAM BUDDHA UNIVERSITY**

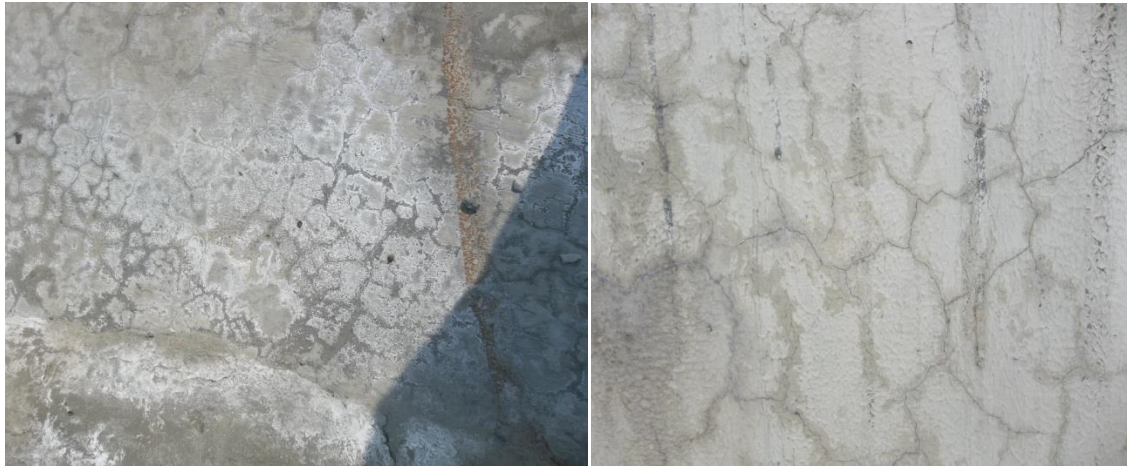
Water tank and parapet walls made up of concrete which are reinforced with the steel bars. Presence of voids cracks in concrete and corrosion of steel bars is the principle cause of the degradation of the structure. Half-Cell potentiometer test is used to evaluate the corrosion activity of reinforcement, its extent and severity. Ultrasound non-destructive digital indicator tester test is use to evaluate the concrete quality. These tests are carried out on water tank slab, its side walls and near parapet walls. White efflorescence had been seen on water tank slab and small cracks on the side wall (Fig. 1.1).

Fig. 1.1: White efflorescence on water tank slab and cracks on side wall

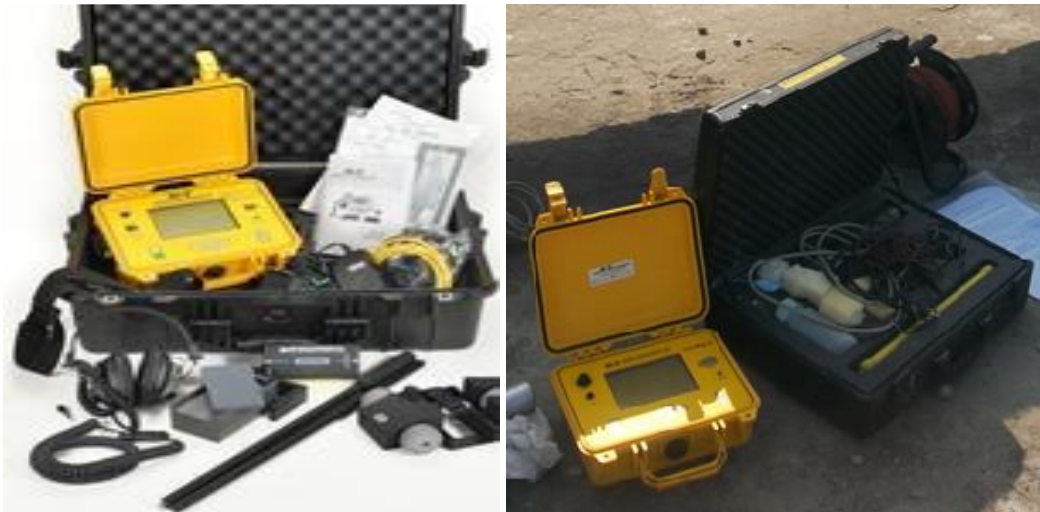
Micro Cover Meter and Half Cell Surveyor

Following equipments were deployed for the corrosion monitoring of reinforcement in concrete (Fig. 3.1)

Fig. 3.1: Equipments used for corrosion investigation

The micro cover meter has been used to locate the rebar. The concrete surface was examined for the exposed rebar or got exposed to get a reference point. Surface was made wet and observation locations were marked on the surface.

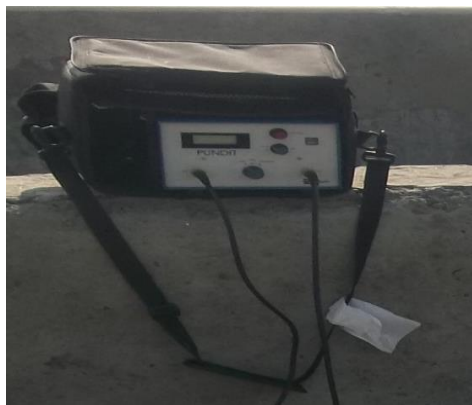
PUNDIT (Fig. 3.2) was used to observe the time of travel of ultrasonic wave between two fixed point at a distance of 50 cm apart. Waves are generated through one transducer and received by another transducer.

Fig. 3.2: Portable Ultrasound Non destructive Digital Indicator Tester Equipment (PUNDIT)

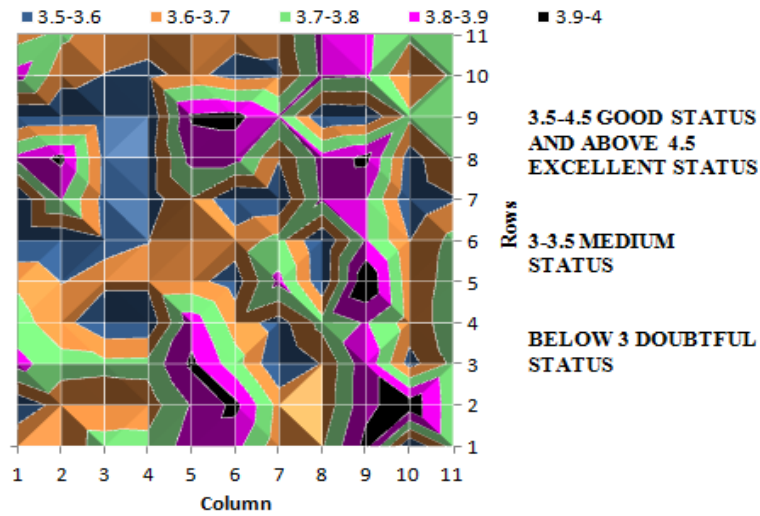
The first grid point of each row was located at a right corner of the water tank slab. The horizontal and vertical grid distance between two points is 30c.m. and 25c.m. respectively. The results shows that concrete in a good quality and test results are presented in Fig. 6.1

Fig. 6.1: Status of Concrete quality based on Pulse Wave Velocity Test

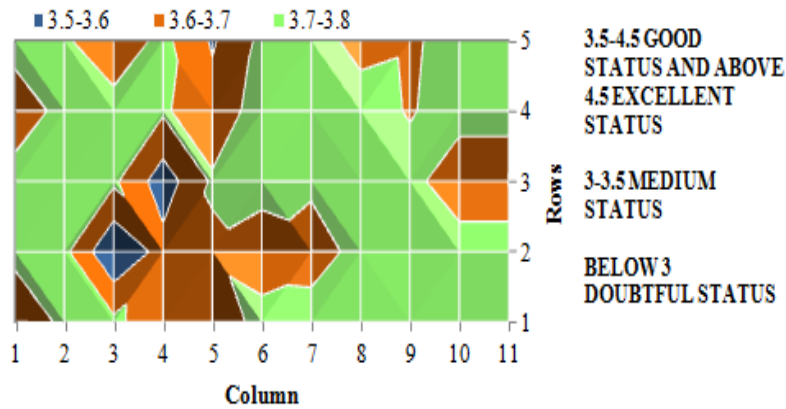
The first grid point of each row was located at a right corner of the water tank wall. Grid distance is 30c.m. horizontally and vertically both side. The results shows that concrete in a good quality and test results are presented in Fig. 6.2

Fig. 6.2: Status of Concrete quality based on Pulse Wave Velocity Test

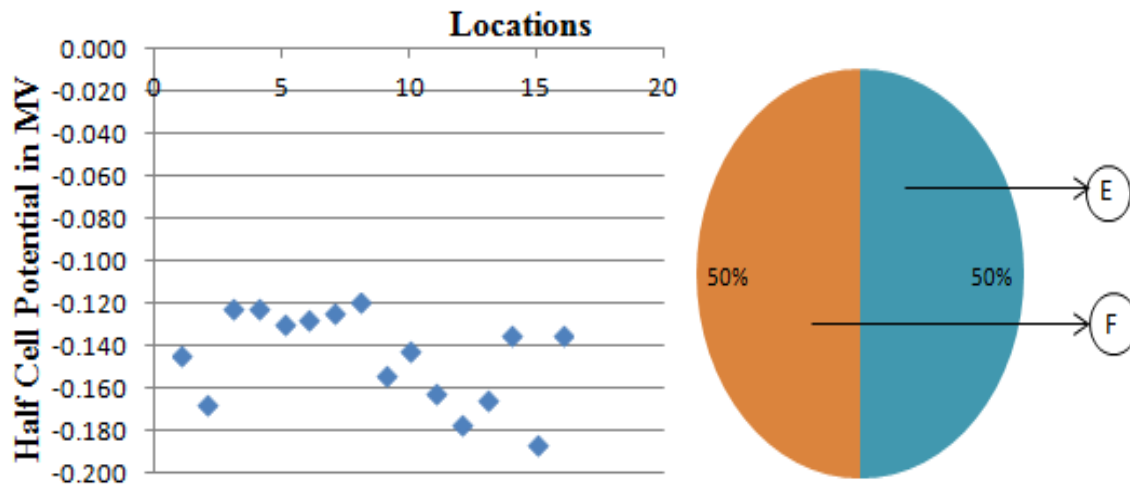
100% area (50% in 'E' and 50% in 'F' categories) falls in area which are indicatives of no noticeable corrosion activity in the scanned area of the wall (Fig. 6.10).

Fig 6.10 Scatter graph showing corrosion status and pie chart of scanned area
