**INTERNATIONAL JOURNAL OF ENGINEERING SCIENCES & RESEARCH  
TECHNOLOGY**

**THE PRESERVATION OF HISTORICAL MASONRY HERITAGE STRUCTURES  
USING ADVANCED COMPOSITE MATERIALS**

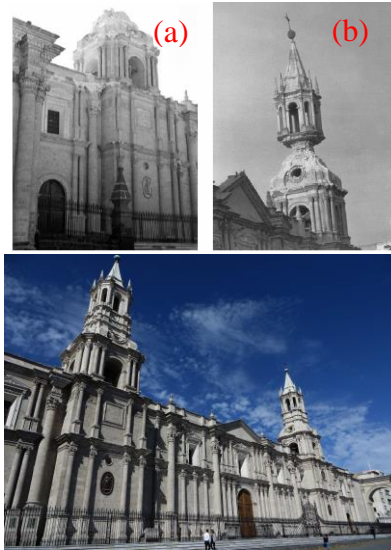
Figure 7 - Towers of Arequipa cathedral after earthquake, (a) Left tower, (b) Right tower<sup>22</sup>

It was first built in 1629. Due to the earthquake of June 23, 2001, that affected most of the southern part of Perú, the towers of the cathedral of Arequipa, built integrally with a volcanic stone called sillar, suffered extensive damage. As a consequence, the left tower partially collapsed, whereas, the right tower remained standing but in an unstable condition (Torrealva et al. 2003). Several reasons make the cathedral the most representative building, it is the highest building in the urban downtown, which is located in the heart of the city, and it is built with sillar. Actually it is the silent witness of important historical events. It is one of the most important classical monuments of Perú. The left tower suffered the collapse of the third and part of the second body; thus, the complete reconstruction of these two bodies was required. The right tower

suffered extensive damage in the second body, losing part of its mass, and finally staying in an unstable equilibrium condition. FRP composites were selected for the rehabilitation project of the cathedral of Arequipa by Torrealva et al. 2003. The reinforcing strategy is described of the masonry right tower of the cathedral with CFRP laminates, which were used to provide tensile strength and confinement to the central core of the tower. An internal steel structure was placed in order to stabilize it for possible aftershocks. It was decided to leave the internal frame in place so the dismantling of the second and third body of the tower was not necessary. The proposed structural intervention consisted of placing additional reinforced concrete columns at the bottom of the tower, next to the pillars, and the rebuilding of the missing part in the second body. The second body was reinforced with CFRP laminates, which were used to provide tensile strength and confinement to that section of the tower. After completing the CFRP installation, carved stones were placed on top of the laminates to keep the original appearance. The reinforcing configuration consisted of vertical CFRP strips. To provide continuity in the section of the second body where a change of cross section and stiffness existed. To restrain the lateral expansion of the second body under axial loads caused by an earthquake, it was determined to place CFRP laminates in the hoop direction. The splice length was staggered along the height to prevent having a weak area prone to debonding of the laminates. A new masonry wall was built with carved sillar blocks on top of the laminates to keep the original appearance of the tower. It was required to anchor the CFRP reinforcement. As part of the overall rehabilitation program an RC ring beam was planned to be built in that region to provide confinement. Thus, it was decided to anchor the FRP reinforcement around that beam. The geometry of the tower was modeled with a commercially available CAD program and the frequencies and vibration modes were computed using a commercially available finite element program, the dynamic analysis of the towers was performed independently of the main structure and with a fixed base as a boundary condition. A static analysis was also performed with horizontal forces. The results of the analyses indicated that the location of the high concentration of stresses was consistent with the damage observed in the tower.

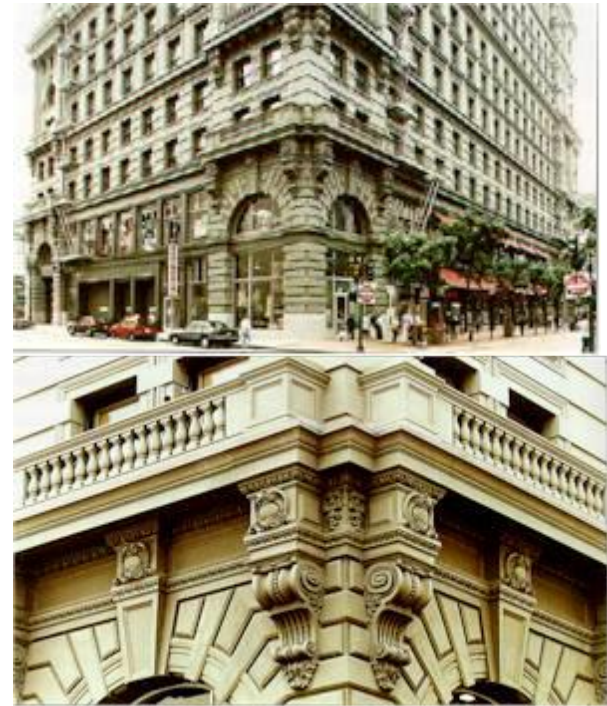
Figure 8 - The historic James E. Flood building in San Francisco USA

**James E. Flood historic building in San Francisco (USA)** Figure (8) involved the main problems of removing sheet metal cladding that was installed, restoring the structure's original, hand-carved sandstone arches, cornices, parapets and balusters. These ornaments were eliminated by a tenant who, 40 years ago, opened up a store on the bottom three floors of the building, removing the building's original hand-carved ornamentation to properly install the sheet metal. Polymer concrete and GFRP were used to retrofit the building. Most of the molds for the cornices and arches were made from the building's original 1903 architectural drawings; some were made directly from existing ornaments. Materials used to make the molds included urethane rubber, FRP and wood materials, depending on the required shape. GFRPs were combined with polyester resin, and hand-laminated into open molds to make the cornices and arches. This combination of materials gave the outer surface of the cornices and arches the appearance of the original sandstone surface. While the cornices were made entirely from FRP, the arches required additional assembly. Once the fiber glass shell laminates were fabricated, the arch panels were anchored to a manufactured tubular steel frame. The frame acted as an intermediary between the fiber glass arch panel and the structural steel of the building. It also helped to keep the panels stiff and simplified their installation. The FRP approach proved to be a light-weight, realistic solution to this challenging renovation. This unique use of FRP in this project earned William Kreysler & Associates the California Preservation Foundation Annual Design Award of 1994, as well as the Composites Fabricators
