### ABSTRACT

This paper deal with modeling of the bend of cladding tube and following realisation of a modeled bend. FEM modeling gave possibility for modeling many combination of the bending parameters and than pick the best combination of a bending parameters. Results, like shear stresses and deformations, obtained from model are listed. Best combination of working parameters was used for the manufacture of a bend. The bended tube was subjected to analysis. The results shown that there are no imperfections like cracks or layers delamination. Results of investigation by SEM including measurement of chemical distribution around interface of cladding tube are shown. For investigation and modeling FEM Software PMD® (Package for Machine Design), SEM microscope Jeol JSM 7600F, optical microscope Nikon Eclipse MA 200 were used.

**KEYWORDS:** FEM model, Bending, Cladding tube, SEM, Light microscopy

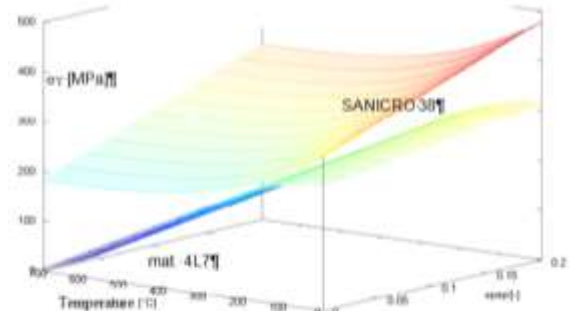
Fig. 2 Approximation of areas of plastification [3]

Firstly was into FEM model set inputs like, mechanical properties and yield strength as function of temperature for both materials. From this data the approximation of areas of plastification was established.

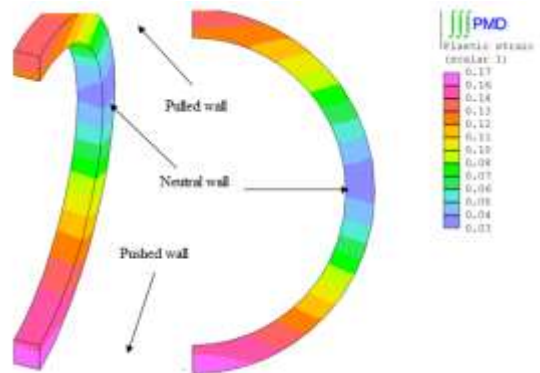
Fig. 3 Scheme of deformations across the tube [3]

Next step was numerical simulation of bending, with focus on deformation and shear stresses. Results of simulations with satisfaction results are shown below.

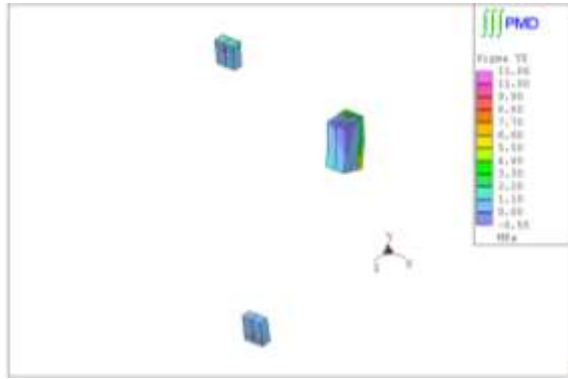
Fig. 3 Shear stresses in the XY plane [3]

Fig. 4 Shear stresses in the XY plane [3]

Fig. 5 Shear stresses in the XY plane [3]

Obtain results from FEM model was compared with experimentally measured values of critical Shear stresses. Model confirmed that stresses caused by bending will be lower than critical. At the base of those results real bend was made.

Values of shear stresses are listed in table 4. Calculated stresses caused by bending are lower than measured critical stress for delamination of layers of cladding tube. That gave chance for successful realization of bend.

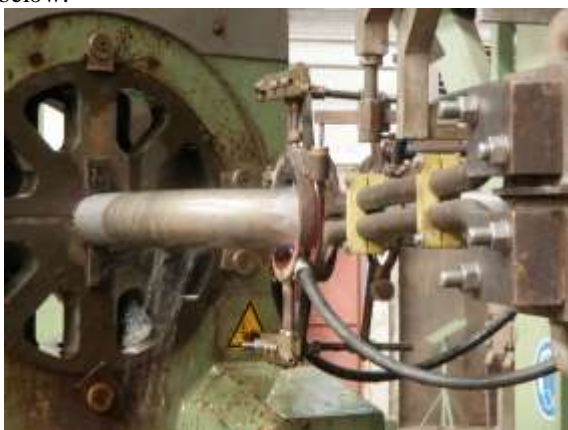
Fig. 6 Side view during bending

Experimental bend was realized on bending machine with inductor heating of tube. Inductor heat small ring of material which is preferably used for location of deformation. Photos taken during bending are shown below.

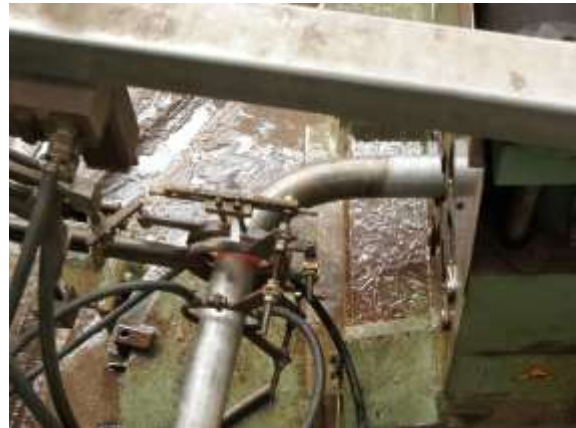
Fig. 7 Upper view during bending

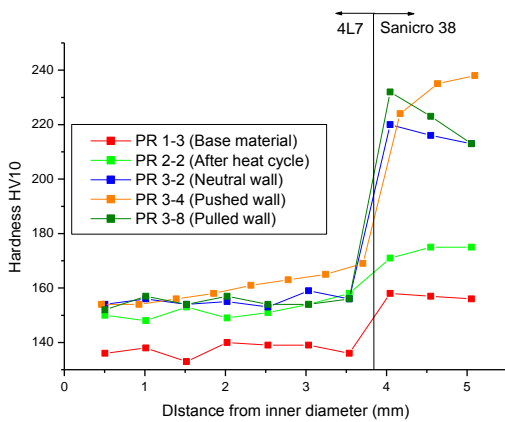
**Fig. 10 Hardness through the wall**

Measurement of hardness through the wall of tube shows that hardness increased by bending just in part of tube made from Sanicro 38. That result is in agreement with calculated values of deformation. No significant difference between pushed and pulled wall aren't occur.

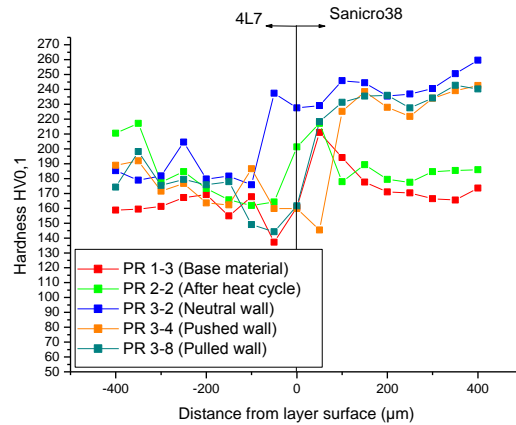
**Fig. 11 Microhardness around cladding surface**

Measurement of microhardness around cladding surface pointed out increase of hardness in close area around cladding surface. That can be caused by redistribution of chemical elements. In figure 12-15 are plotted difference of chemical elements content in counts from EDX analysis. Area from 40 to 50 µm is rich for all alloying elements which contain Sanicro 38. It confirm diffusion from Sanicro 38 into 4L7. On the other hand Figure 9 had shown carbon diffusion from 4L7 into Sanicro 38. These two changes was caused by heat cyclus and caused increasing of hardness around cladding surface.

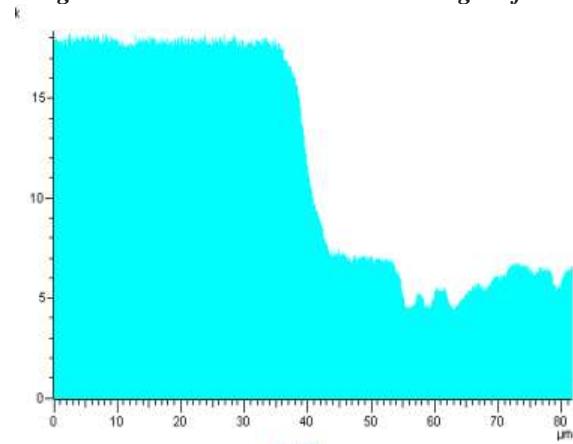
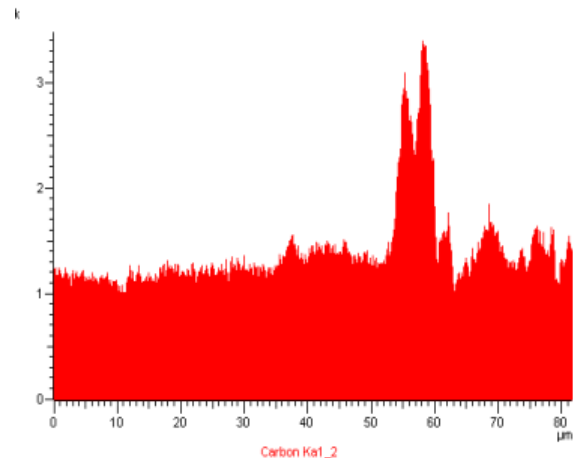
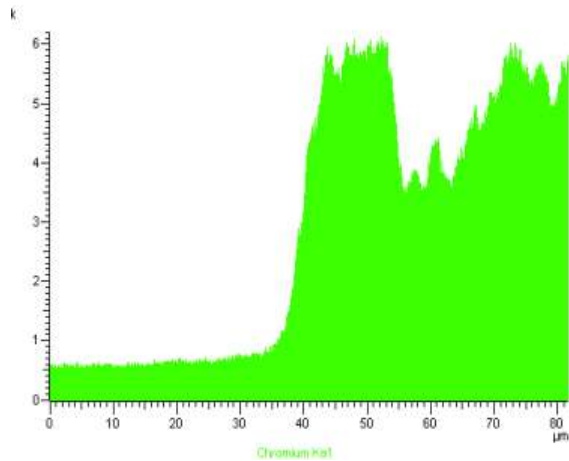
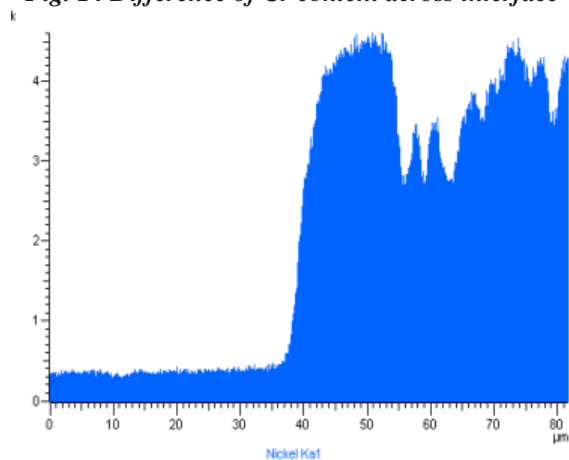
**Fig. 12 Difference of Fe content across interface**

**Fig. 13 Difference of C content across interface**

Fig. 14 Difference of Cr content across interface

Fig. 15 Difference of Ni content across interface
