International Journal of Engineering Sciences & Research Technology

Fly ash disposal & utilisation is becoming of a national concern due to increasing pollution issues and its efficient management to prevent further degradation of environmental pollution. At present, generation of flyash is in tune of about 130 million tone and likely to be increased in future. Thermal power plants (TPPs) generate a huge amount of fly ash during combustion of coal and face fly ash management problems. Open dumping of fly ash can deteriorate the groundwater quality by runoff. In the present investigation, an attempt has been made to evaluate ground/surface water quality situated near thermal power plant (PTPP) located in eastern UP state in India. Water, flyash and coal samples from various locations in and around PTPP were collected and subjected to insitu and physico-chemical analysis. Coal samples found high ash content. pH values of ground water samples found acidic character with high conductivity values. Physico-chemical analysis of flyash and water extract indicated leaching tendency of soluble ions into water which enhance over a period of time. Urgent need towards flyash utilization & mana

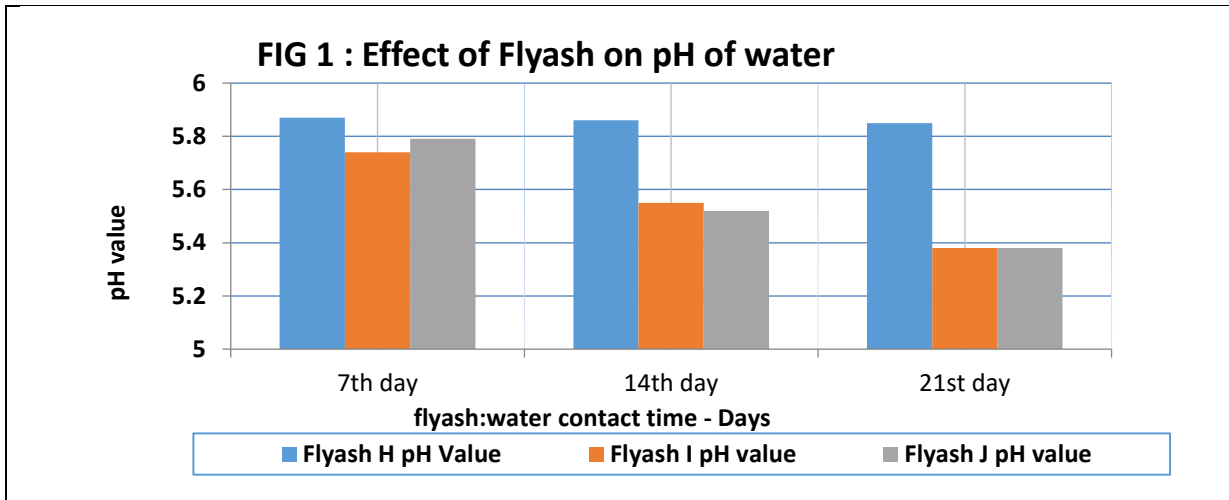
4.1 Impact of flyash on pH and conductivity of water

4.4.1 pH and conductivity (FIG 1&2): pH value falls sharply for fly ash samples I&J in initial stages and remains acidic through out of the period and contribute major acidity in water. General increase in conductivity was noticed for all flyash samples w.r.t. time indicate flyash contribute majority of inorganic ions in water. Further, in situ analysis of ground water samples indicate the high value of conductivity and low pH (Table 2) which correlate the possible effect of fly ash in ground water contamination.

Three flyash samples collected from the project (Sample Nos H, I & J; Table 1) used to make 1:10 fly ash-distilled water suspensions. The suspensions were analysed for various physico-chemical parameters at different time intervals i.e. 7th, 14th and 21st day. Effect of flyash on pH and conductivity values of water are shown in Fig 1&2. The leaching of cations and anions from flyash into water have been represented in Fig. 3 to 9 for different interaction time intervals..

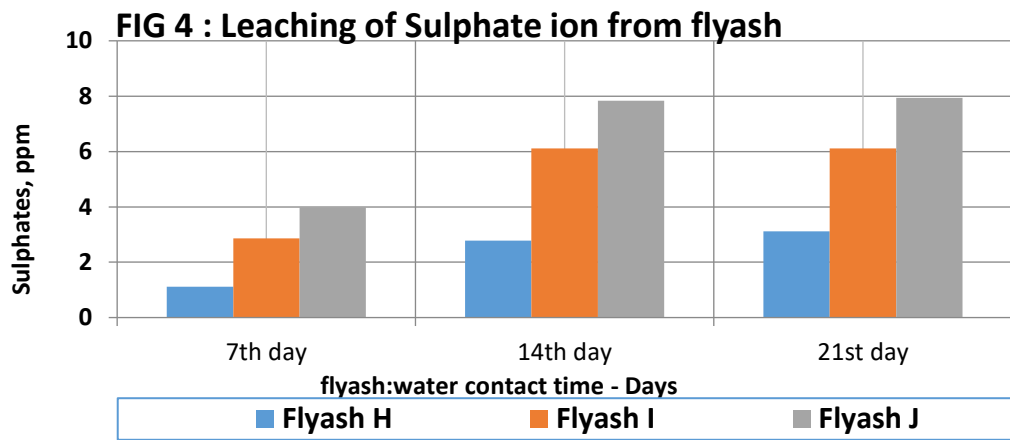
4.2 Impact of flyash contribution of anions in water

4.4.2 Physico chemical parameters (Anions and cations): Fig. 3 to 5 indicates increase in leaching effect of major anions viz. bicarbonate, chloride and sulphate anions in water from flyash with respect to time. Fig. 6 to 9 indicates increase in leaching effect of major cations like calcium, magnesium, sodium and potassium in water from flyash with respect to time. The study generally shows that flyash tend to leach major anions and cations in water. [6][7]
